# Specification Update

## PXA3xx (88AP3xx) Processor Family

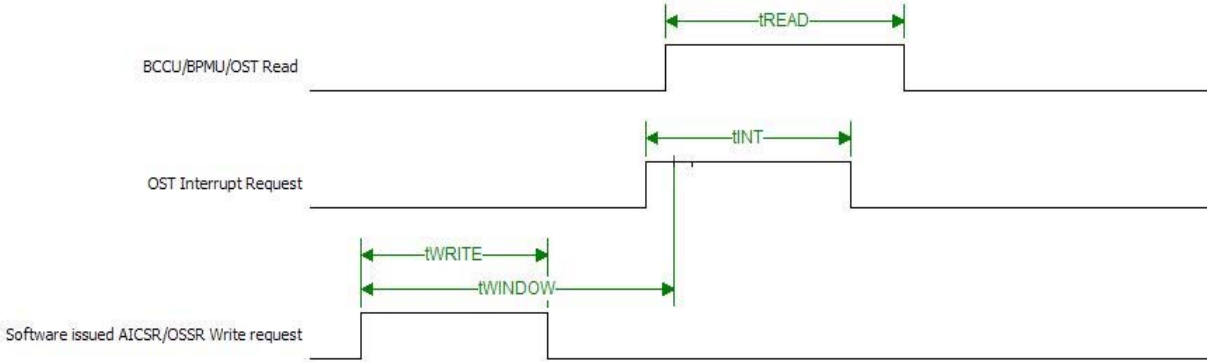
**Figure 1: Single OS Timer Match Event with an OSSR Write failure window**

- $t_{WRITE}$ : Register write request
- $t_{INT}$ : duration of interrupt service request (100 ns - 200 ns)
- $t_{WINDOW}$ : Time between OSSR/AICSR write and the interrupt request. To avoid failure window must be greater than 550 ns.
- $t_{READ}$ : Time which the ACCU/APMU/OST read request must be received
