Colibri iMX6 Errata

Errata Document

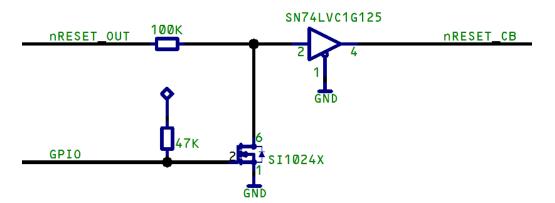
Errata #2: Software imitated reset cycle does not assert nREST_OUT

During a software initiated reset cycle, the nRESET_OUT signal is not asserted on the Colibri iMX6 V1.0 module. Unlike other Colibri modules, the nRESET_OUT signal remains the whole time high during the software initiated reset.

During power up as well as hardware initiated reset cycles (by pressing the nRESET_IN/RESET_EXT button), the nRESET_OUT signal gets asserted similar to other Colibri modules. This is not an issue as long as external peripheral devices on the carrier board do not need to be reset during a software reset or no software initiated reset cycles are used on a system.

A possible workaround is implementing a small reset circuit on the carrier board that allows driving low the reset signal by using any free GPIO:

Since on the Colibri iMX6 the reset state of regular GPIOs is configured as input with enabled internal pull up resistor, the transistor will pull down the reset line during a software initiated reset cycle. The bootloader or application needs to reconfigure the GPIO as output and drive it low for releasing the external reset signal.
