# **Iris Carrier Board**

Errata Document

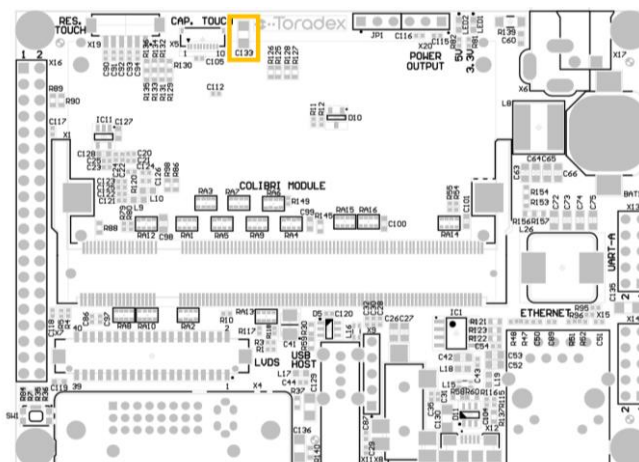
An assembly issue affecting an early production lot of the Iris V2.0A is causing a violation of a keep-out zone defined for Colibri SoMs featuring an FFC connector on the bottom. These SoMs may not be appropriately inserted into the module connector of the affected carrier boards, potentially resulting in connection or reliability issues.

An early production lot of the Iris V2.0A is affected by an assembly issue. The assembled capacitor C133 (Figure 1) violates a keep-out zone defined for Colibri SoMs featuring an FFC connector on the bottom. These SoMs may not be appropriately inserted into the module connector of the affected carrier boards, potentially resulting in connection or reliability issues.

Figure 1: Incorrectly assembled C133 highlighted

Removal of the capacitor C133 fully resolves the issue. The modification does not impact carrier board functionality. C133 is not assembled on later production lots of the Iris V2.0A.
