# Apalis iMX6

## Errata Document

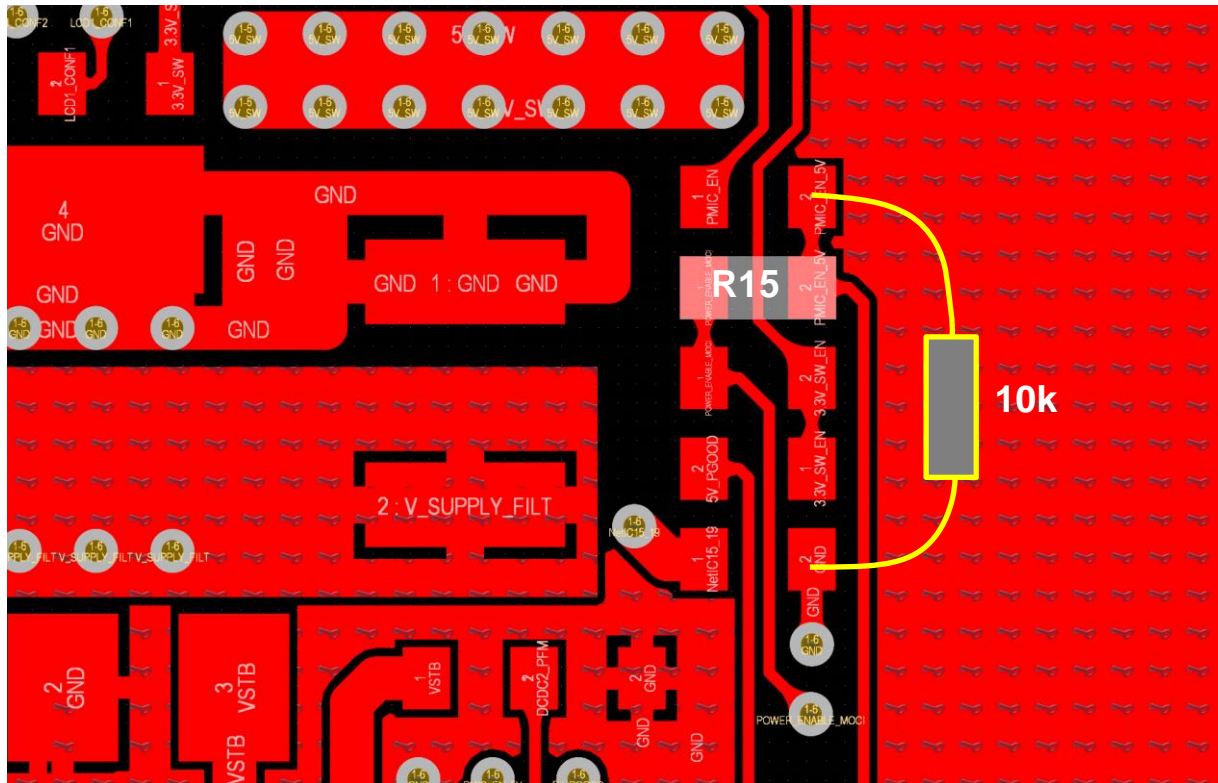
Depending on the carrier board and the amount of backfeeding, the POWER\_ENABLE\_MOCI might not go low enough to turn off the peripheral voltage rails in the shutdown state.

The POWER\_ENABLE\_MOCI signal is intended to be used for switching the peripheral voltage rails on the carrier board, like the 5V\_SW and 3.3V\_SW on the Ixora. Depending on the amount of backfeeding over the interface signals from the carrier board to the Apalis iMX6 module, the POWER\_ENABLE\_MOCI signal can remain between 1.0V and 1.4V in module shutdown. Depending on the carrier board circuit, this can be too high for turning off the peripheral voltage rails.

For example, on the Ixora V1.2, a different buck converter for the 5V\_SW is used than on the previous versions. The threshold voltage for the enable signal is lower on the new buck converter. Depending on the backfeeding level, the 5V\_SW buck converter does not get disabled in the shutdown state. The Ixora V1.0 and V1.1 are not affected by this issue since they have been using a different buck converter with a higher threshold.

Figure 1 Possible voltage divider workaround on Ixora V1.2

Add a circuit to the carrier board for increasing the POWER\_ENABLE\_MOCI threshold voltage to between 2.0V and 2.5V. This could be achieved by adding a comparator or similar circuit. Such a solution is implemented in the V1.3 revision of the Ixora.

A simple voltage divider added to the POWER\_ENABLE\_MOCI signal can shift the voltage levels. Important: make sure that the minimum input voltage for enabling the buck converter is still guaranteed. With the AOZ2260 buck converter (which is used on Ixora V1.2), a 10k/10k voltage divider can be a suitable option. For patching such a divider, replace R15 with a 10k 0603 resistor and add another 10k resistor from the PMIC\_EN\_5V signal to the ground.
