Verdin Development Board

Errata Document

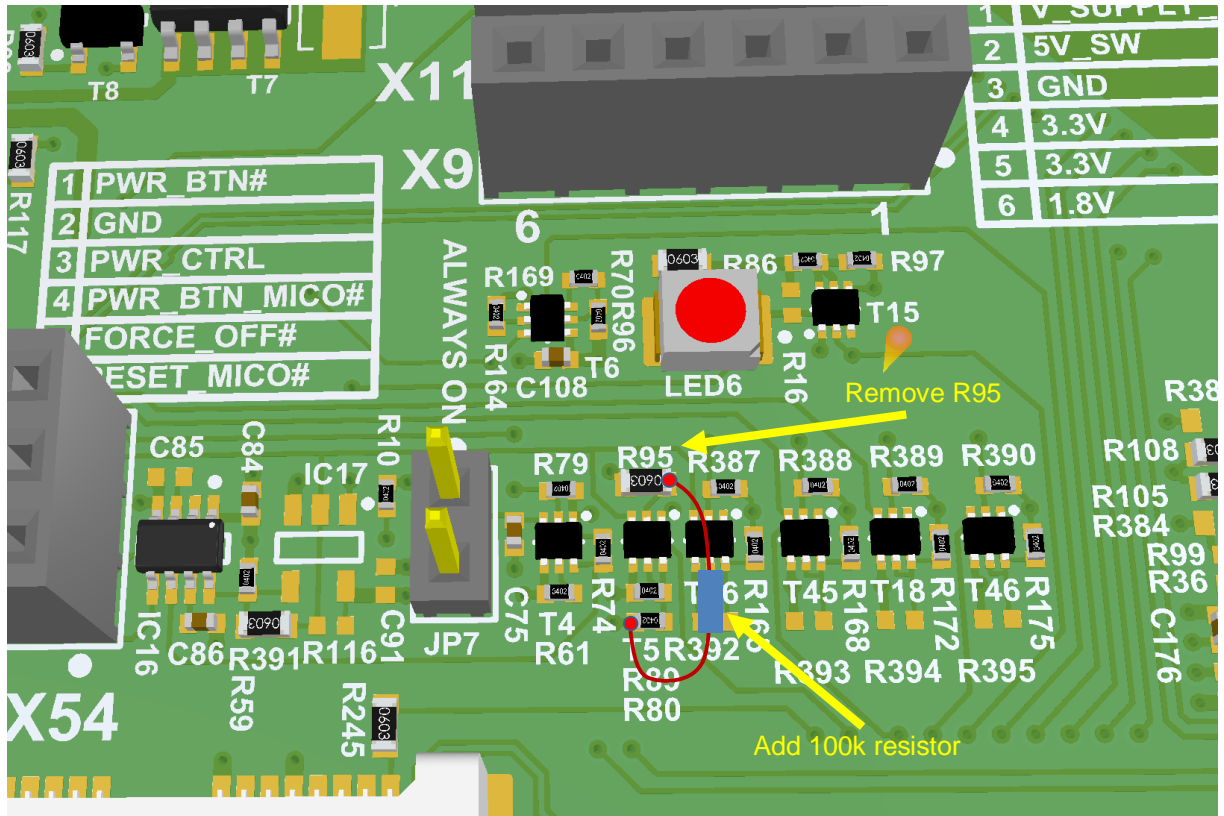
Figure 1 Verdin Development Board CTRL_FORCE_OFF_MOC1# pull-up patch (Top Side)

Errata #4: HAR-3935 – CTRL_FORCE_OFF_MOCI# is pulled-up to wrong voltage rail

According to the Verdin specifications, the CTRL_FORCE_OFF_MOCI# is an open-drain output of the module, which is 5V tolerant and requires a pull-up resistor on the carrier board. On the Verdin Development Board V1.0B, the CTRL_FORCE_OFF_MOCI# is pulled up to the +V1.8_SW rail. Unfortunately, this rail is switched by the CTRL_PWR_EN_MOCI# signal. During a reset cycle (software or button initiated), the CTRL_PWR_EN_MOCI# signal can go low for power cycling the peripherals on the carrier board. This is also disabling the +V1.8_SW, which means the CTRL_FORCE_OFF_MOCI# goes low and triggers the kill input of IC16. The IC16 will then kill the main power of the module. This means resetting the module can cause an unintentional power-off of the system.

During a regular power-down cycle, the CTRL_FORCE_OFF_MOCI# signal is supposed to go low as the last step after all the module and carrier board peripheral rails are shut down in the correct order. Due to the incorrectly pulled up CTRL_FORCE_OFF_MOCI# signal, the main power gets killed in a too early state. This means the power rails are not shut down in the intended graceful sequence. Even with this non-graceful shutdown, damages on the module or carrier board are not expected.

An alternate workaround is removing R95 and adding a 100kΩ pull-up resistor from CTRL_FORCE_OFF_MOCI# to +V5_STB. This makes the circuit fully compatible with the new Verdin modules. The kill-feature would work with this modification as intended with the new Verdin modules. However, for the older Verdin iMX8M Mini V1.0B module, the CTRL_FORCE_OFF_MOCI# is not 5V tolerant and the CTRL_FORCE_OFF_MOCI# signal gets also asserted during the reset cycle. This means after the modification, the development board is not compatible anymore with the Verdin iMX8M Mini V1.0B. Read Errata #13 and Errata #5 of the Verdin iMX8M Mini V1.0B module for more information. The following picture shows one potential implementation of the alternate workaround patch:

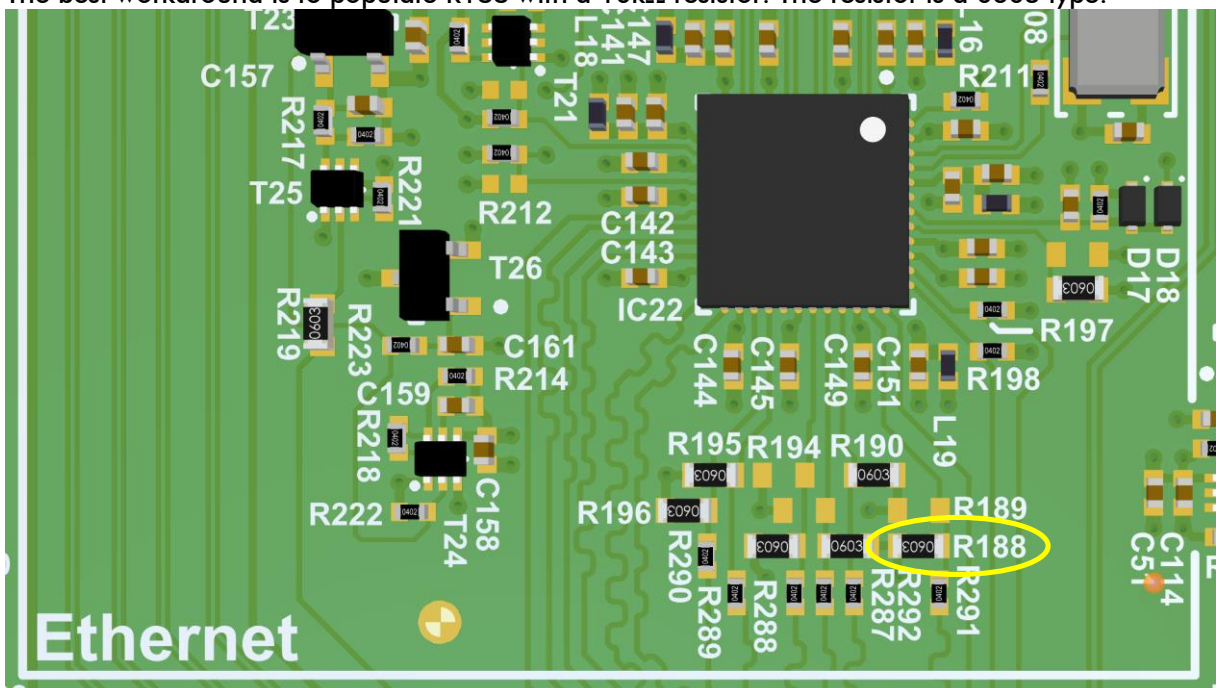
Figure 2 Verdin Development Board – location of R188 (Top Side)

Errata #5: HAR-6600 – Ethernet PHY address strapping resistor for configuring PHYAD2 missing

The last three bits of the PHY address are strapped by the PHYAD0, PHYAD1, and PHYAD2 pin. PHYAD0 and PHYAD1 are located on the LED output signals, which are strapped correctly. PHYAD2 is located on the RXC pin of the PHY (ETH_2_RGMII_RXC signal). The strapping resistors R188 and R189 are both missing in the BOM. Intended by design is to strap the signal high by assembling R188. Since both strapping resistors are missing, the strapping value is dictated by the module’s behavior of the ETH_2_RGMII_RXC signal during the enabling of the Ethernet power rails. The Ethernet power rails are enabled on the carrier board by the PWR_CTRL_4 signal.

The Verdin iMX8M Plus has a weak pull-down enabled on the ETH_2_RGMII_RXC by default. Therefore, the PHY address gets strapped to 0b00011 rather than the intended 0b00111. In this case, the module can only communicate over the MDIO interface with the PHY if the driver changes the address to 0b00011.

The best workaround is to populate R188 with a 10kΩ resistor. The resistor is a 0603 type.
