Apalis iMX8

Errata Document

Errata #2: HAR-4106 – Power on after SW shut-down not possible

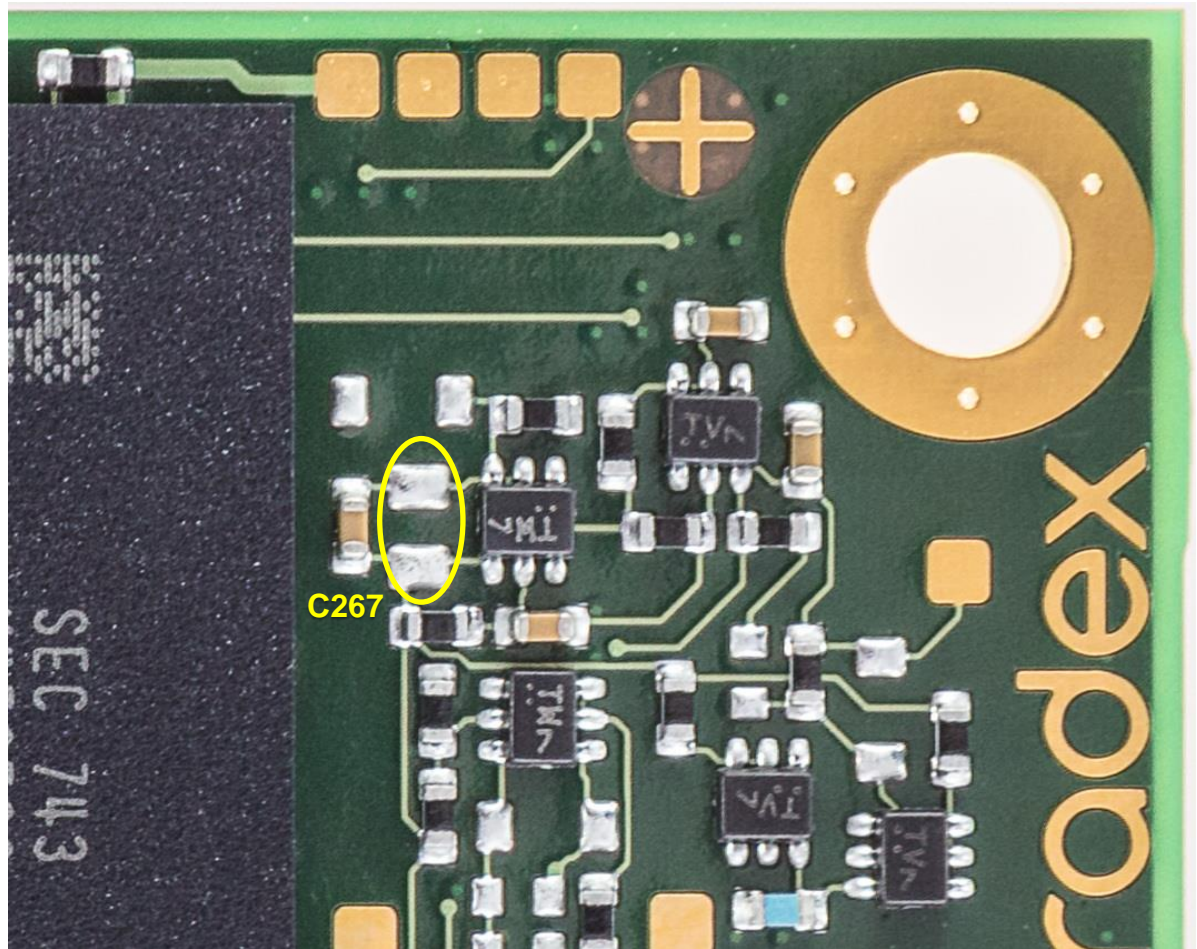
Figure 1. Location of C267 (top side, top view)

Unfortunately, the power button pulse that is generated is too short. The SoC does not get out of the power-off state, and therefore the PMIC is not turned on. The module does not start if the RTC rail is retained during the main voltage power cycle (VCC). The module can also not be started by pressing the reset button (RESET_MICO#). The only way to start the module after the PMIC is put to power-off is to remove the RTC rail together with the main module rail.

Option 2: Assemble C267 for making the power button signal pulse long enough. The capacitor C267 is not assembled on Apalis iMX8 modules with version 1.1A or older. By assembling C267 with a 10µF 6.3V capacitor with the 0603 size. The power button signal pulse gets its required duration. This means the module can be turned on either by power cycling VCC or by pressing the RESET_MICO# button
