Apalis iMX8

Errata Document

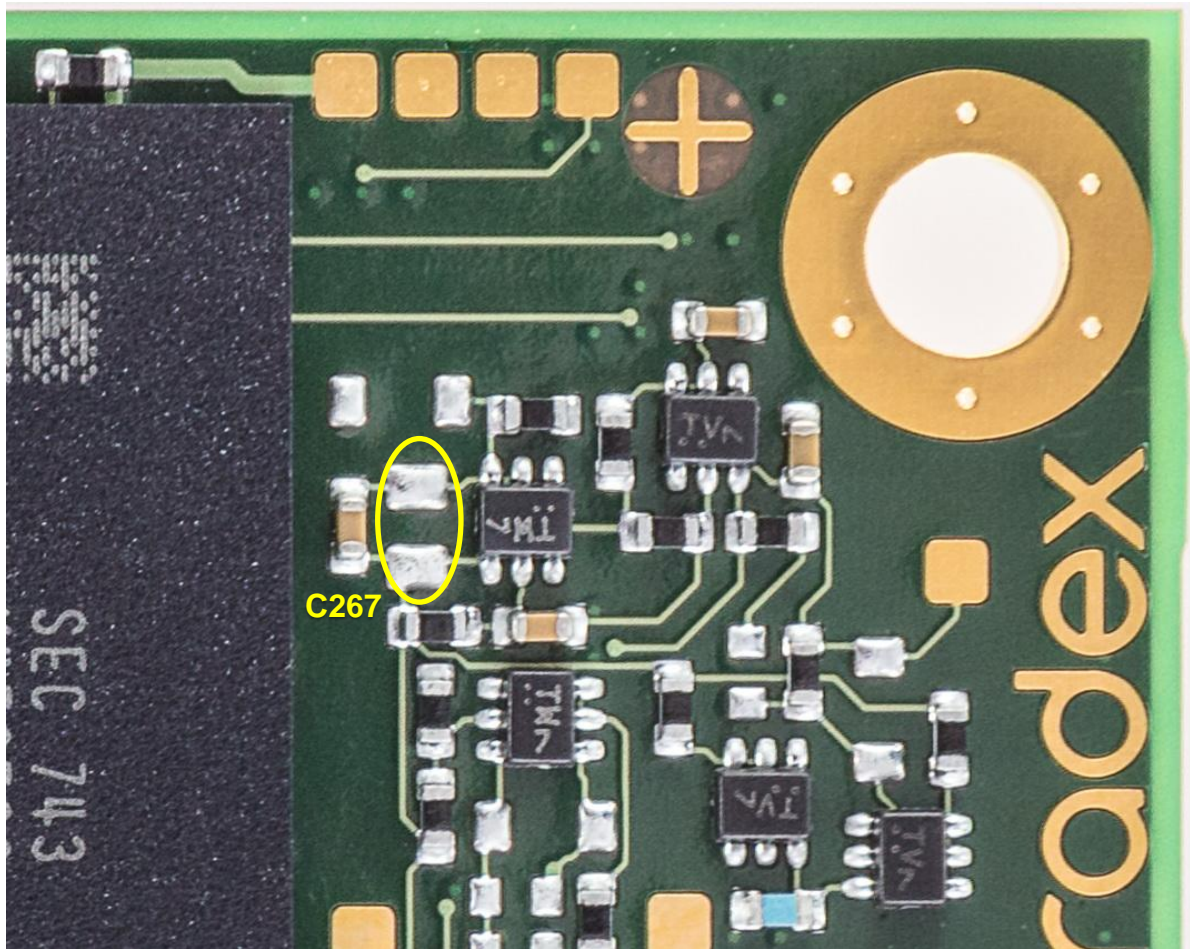
Figure 1. Location of C267 (top side, top view)

Unfortunately, the power button pulse that is generated is too short. The SoC does not get out of the power-off state, and therefore the PMIC is not turned on. The module does not start if the RTC rail is retained during the main voltage power cycle (VCC). The module can also not be started by pressing the reset button (RESET_MICO#). The only way to start the module after the PMIC is put to power-off is to remove the RTC rail together with the main module rail.

Option 2: Assemble C267 for making the power button signal pulse long enough. The capacitor C267 is not assembled on Apalis iMX8 modules with version 1.1A or older. By assembling C267 with a 10 μ F 6.3V capacitor with the 0603 size. The power button signal pulse gets its required duration. This means the module can be turned on either by power cycling VCC or by pressing the RESET_MICO# button

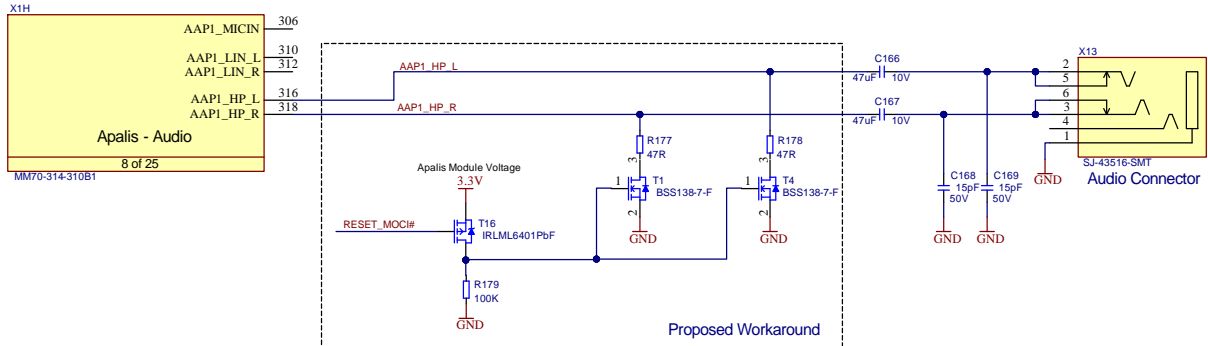
Figure 2. Proposed headphone capacitor discharge circuit

If headphones are plugged in during a software reboot, the voltage at the series capacitors is backfeeding to the power rails of the audio codec. The series capacitors are not fully discharged since the power rails are turned off only for around 5ms. The voltage at the 3.3V analog rail of the audio codec remains at about 1.5V. The residual voltage can cause the audio codec not to reset properly. This reset issue can prevent the audio codec from functioning properly. Power cycling the SoM resolves the problem.

If the audio codec needs to be reliably reset when used in combination with low-impedance headphones, an additional discharge circuit can be added to the carrier board. The idea behind this circuit is to discharge the series capacitors while the RESET_MOCI# signal is low. A resistor value of 47R is a good choice for series capacitors with values between 47 μ F and 100 μ F.
