Verdin iMX8M Plus

Errata Document

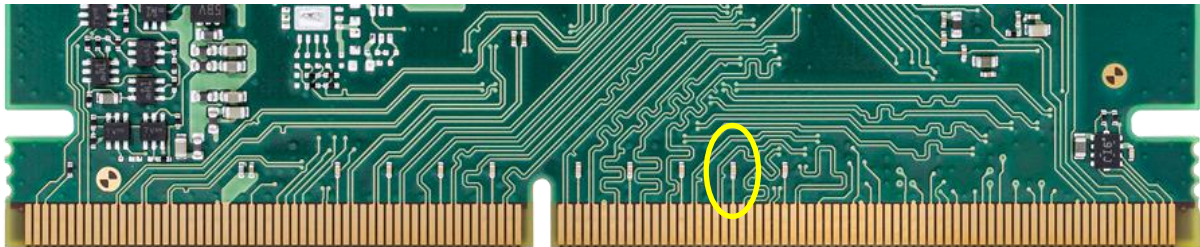
Figure 1 Location of C210 (Bottom Side)

The Bluetooth solution is not accessible by the system as the host interface strapping signal of the Bluetooth solution is unintentionally influenced by a stitching capacitor on the SoM. This leaves the Bluetooth solution in the UART interface mode instead of SDIO.

The signal used for strapping the HCI (Host Controller Interface) configuration of the Bluetooth solution at the time of powering up the SoM is also available on the Module-specific pin MSP_8 (#104) of the SoM edge connector. Module-specific pins feature stitching capacitors for providing current return paths for cases when those pins are being used for accommodating high-speed signals.

The Verdin iMX8M Plus V1.0B configurations equipped with a Wi-Fi/Bluetooth solution feature one such capacitor (C210) on the MSP_8 signal. During powering up the system, the stitching capacitor delays the transition of the related signal to the intended state and thus results in a wrong configuration being strapped. Instead of SDIO mode, the host interface of the Bluetooth solution gets configured to UART mode. As a result, the Bluetooth solution is not accessible by the system.

Remove the stitching capacitor C210 from the SoM. This makes the Bluetooth interface work in case the SoM is connected to a Dahlia V1.1A carrier board.

If the SoM is connected to a Verdin Development Board V1.1A, then other stitching capacitors need to be removed from the carrier board as well. The issue will be resolved in future HW versions of these products. Please refer to HAR-8342 in the Verdin Development Board errata for more information.
