# **Apalis iMX8X**

## **Errata Document**

Errata #1: HAR-8349 – POWER\_ENABLE\_MOCI indeterminate due to

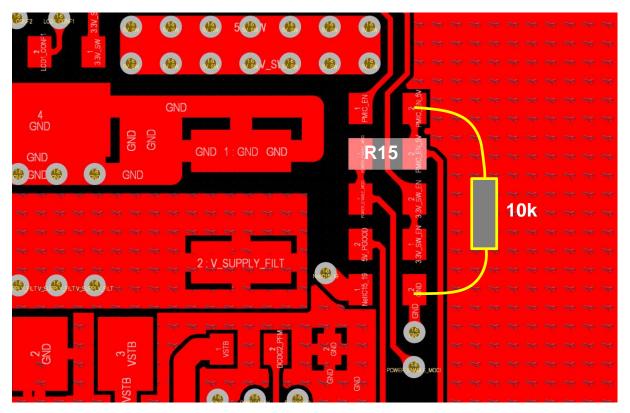
The POWER\_ENABLE\_MOCI signal is intended to be used for switching the peripheral voltage rails on the carrier board, like the 5V\_SW and 3.3V\_SW on the lxora. Depending on the amount of backfeeding over the interface signals from the carrier board to the Apalis iMX8X module, the POWER\_ENABLE\_MOCI signal can remain between 1.0V and 1.4V in module shutdown. Depending on the carrier board circuit, this can be too high for turning off the peripheral voltage rails.

For example, on the Ixora V1.2, a different buck converter for the 5V\_SW is used than on the previous versions. The threshold voltage for the enable signal is lower on the new buck converter. Depending on the backfeeding level, the 5V\_SW buck converter does not get disabled in the shutdown state. The Ixora V1.0 and V1.1 are not affected by this issue since they have been using a different buck converter with a higher threshold.

Figure 1 Possible voltage divider workaround on Ixora V1.2

Add a circuit to the carrier board for increasing the POWER\_ENABLE\_MOCI threshold voltage to between 2.0V and 2.5V. This could be achieved by adding a comparator or similar circuit. Such a solution is implemented in the V1.3 revision of the Ixora.

A simple voltage divider added to the POWER\_ENABLE\_MOCI signal can shift the voltage levels. Important: make sure that the minimum input voltage for enabling the buck converter is still guaranteed. With the AOZ2260 buck converter (which is used on Ixora V1.2), a 10k/10k voltage divider can be a suitable option. For patching such a divider, replace R15 with a 10k 0603 resistor and add another 10k resistor from the PMIC\_EN\_5V signal to the ground.
