Verdin Development Board

Errata Document

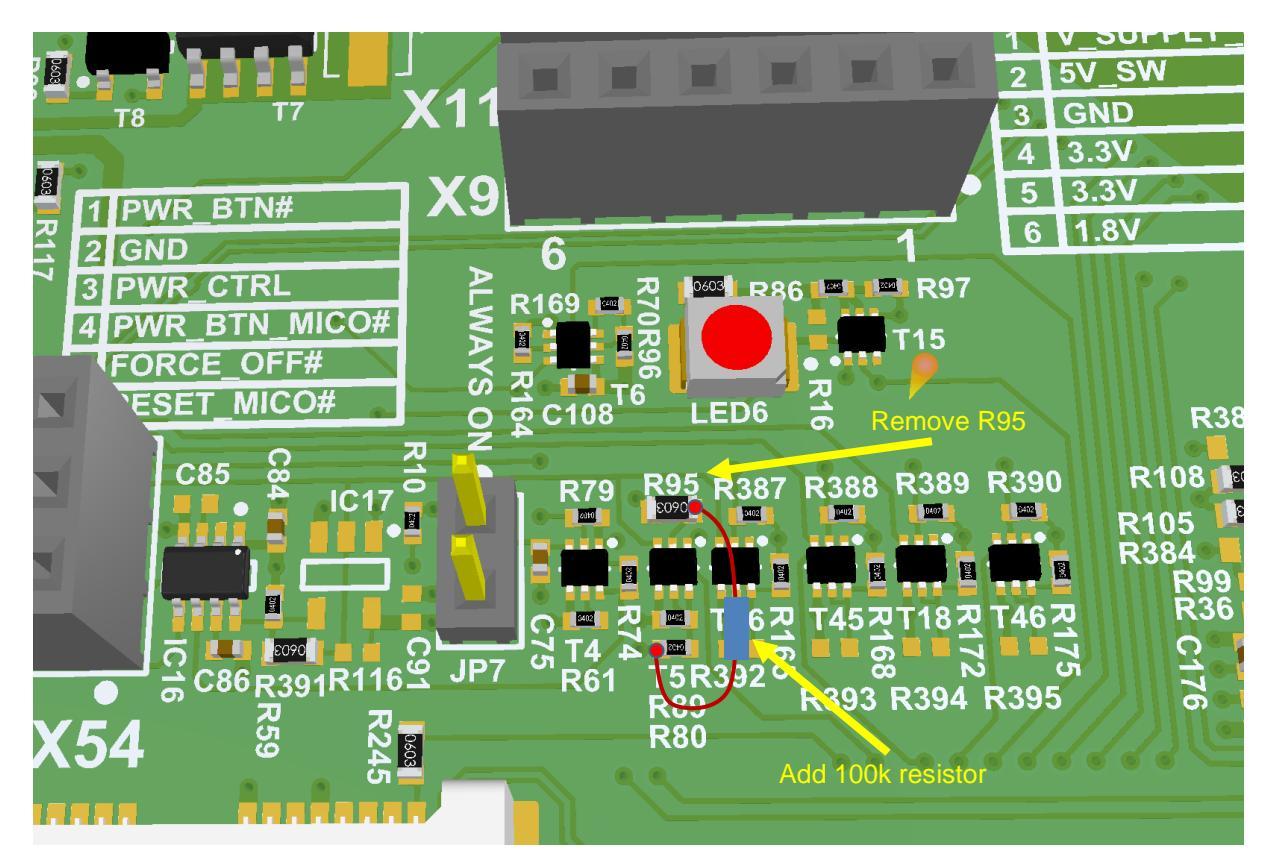
Figure 1. Verdin Development Board CTRL_FORCE_OFF_MOCI# pull-up patch (Top Side)

Errata #4: HAR-3935 – CTRL_FORCE_OFF_MOCI# is pulled-up to wrong voltage rail

The main power gets killed when the CTRL_PWR_EN_MOCI# goes low and the +V1.8_SW rail is turned off. This means the main power is killed during a reset cycle, and the power-down sequence is not graceful.

According to the Verdin specifications, the CTRL_FORCE_OFF_MOCI# is an open-drain output of the module, which is 5V tolerant and requires a pull-up resistor on the carrier board. On the Verdin Development Board V1.0B, the CTRL_FORCE_OFF_MOCI# is pulled up to the +V1.8_SW rail. Unfortunately, this rail is switched by the CTRL_PWR_EN_MOCI# signal. During a reset cycle (software or button initiated), the CTRL_PWR_EN_MOCI# signal can go low for power cycling the peripherals on the carrier board. This is also disabling the +V1.8_SW, which means the CTRL_FORCE_OFF_MOCI# goes low and triggers the kill input of IC16. The IC16 then kills the main power of the module. This means resetting the module can cause an unintentional power-off of the system.

An alternate workaround is removing R95 and adding a 100kΩ pull-up resistor from CTRL_FORCE_OFF_MOCI# to +V5_STB. This makes the circuit fully compatible with the new Verdin modules. The kill-feature would work with this modification as intended with the new Verdin modules. However, for the older Verdin iMX8M Mini V1.0B module, the CTRL_FORCE_OFF_MOCI# is not 5V tolerant, and the CTRL_FORCE_OFF_MOCI# signal gets also asserted during the reset cycle. After the modification, the development board is no longer compatible with the Verdin iMX8M Mini V1.0B. Read Errata #13 and Errata #5 of the Verdin iMX8M Mini V1.0B module for more information. The following picture shows one potential implementation of the alternate workaround patch:

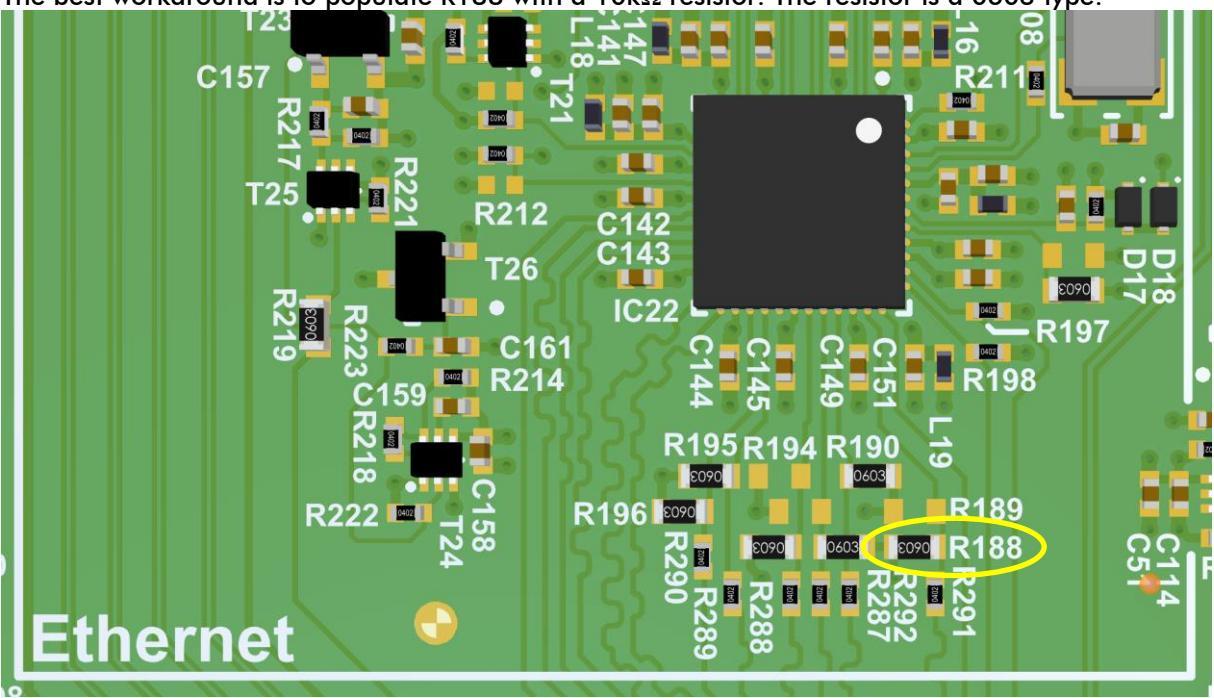
Figure 2. Verdin Development Board - location of R188 (Top Side)

Errata #5: HAR-6600 – Ethernet PHY address strapping resistor for configuring PHYAD2 missing

In combination with the Verdin iMX8M Plus, the Ethernet PHY on the carrier board (which is connected to the RGMII interface of the SoM) gets strapped to address 0b00011 rather than the intended 0b00111. This address is not compatible with the default address configuration used in applicable Toradex software, causing the 2nd Ethernet interface of the carrier board to be non-functional. The strapped value and the resulting PHY address may be different in combination with future Verdin modules.

The last three bits of the PHY address are strapped by the PHYAD0, PHYAD1, and PHYAD2 pin. PHYAD0 and PHYAD1 are located on the LED output signals, which are strapped correctly. PHYAD2 is located on the RXC pin of the PHY (ETH_2_RGMII_RXC signal). The strapping resistors R188 and R189 are both missing in the BOM. Intended by design is to strap the signal high by assembling R188. Since both strapping resistors are missing, the strapping value is dictated by the module's behavior of the ETH_2_RGMII_RXC signal during the enabling of the Ethernet power rails. The Ethernet power rails are enabled on the carrier board by the PWR_CTRL_4 signal.

The Verdin iMX8M Plus has a weak pull-down enabled on the ETH_2_RGMII_RXC by default. Therefore, the PHY address gets strapped to 0b00011 rather than the intended 0b00111. In this case, the module can only communicate over the MDIO interface with the PHY if the driver changes the address to 0b00011.

The best workaround is to populate R188 with a $10k\Omega$ resistor. The resistor is a 0603 type.

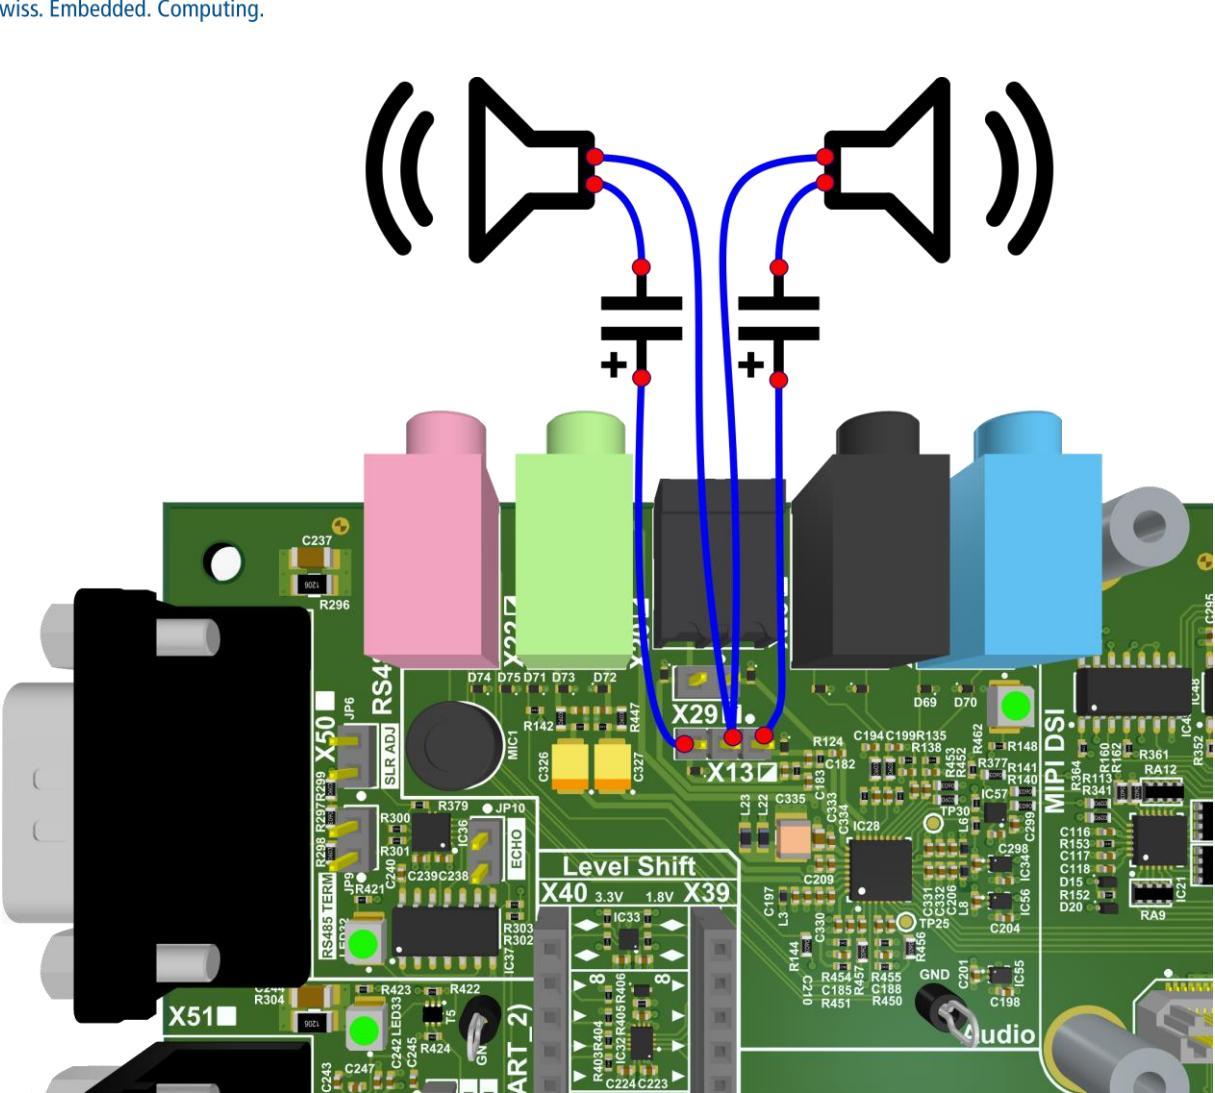
Figure 3. Verdin Development Board – connection of the external speakers in a stereo setup, with external series capacitors

Errata #6: HAR-7206 – Series capacitor values are too small for the audio codec's speaker output to be used in a stereo setup

The audio output is significantly attenuated or not audible at all when the audio codec's speaker output is used in combination with external speakers connected in a stereo setup.

In a stereo setup, two external speakers are connected to the connector X13. In this case, one end of each speaker's coil is connected to the common ground pin (GND), the other ends are connected to the audio codec IC through the capacitors C182 or C183, respectively.

The capacitors C182 (1uF) and C183 (1uF), in conjunction with the speaker's impedance (80hm), form high-pass filters. The cut-off frequency of the high-pass filters is around 20 kHz.

A partial workaround has already been applied to the Verdin Development Board V1.1A: 00hm resistors have assembled instead of the capacitors C182 and C183. To complete the workaround, external capacitors connected in series with the external speakers are required (see Figure 3).

For 80hm speakers, we recommend using either 220uF series capacitors for a cut-off frequency of approximately 90Hz or 470uF for 42Hz respectively (minimum 6.3V rated in both cases).

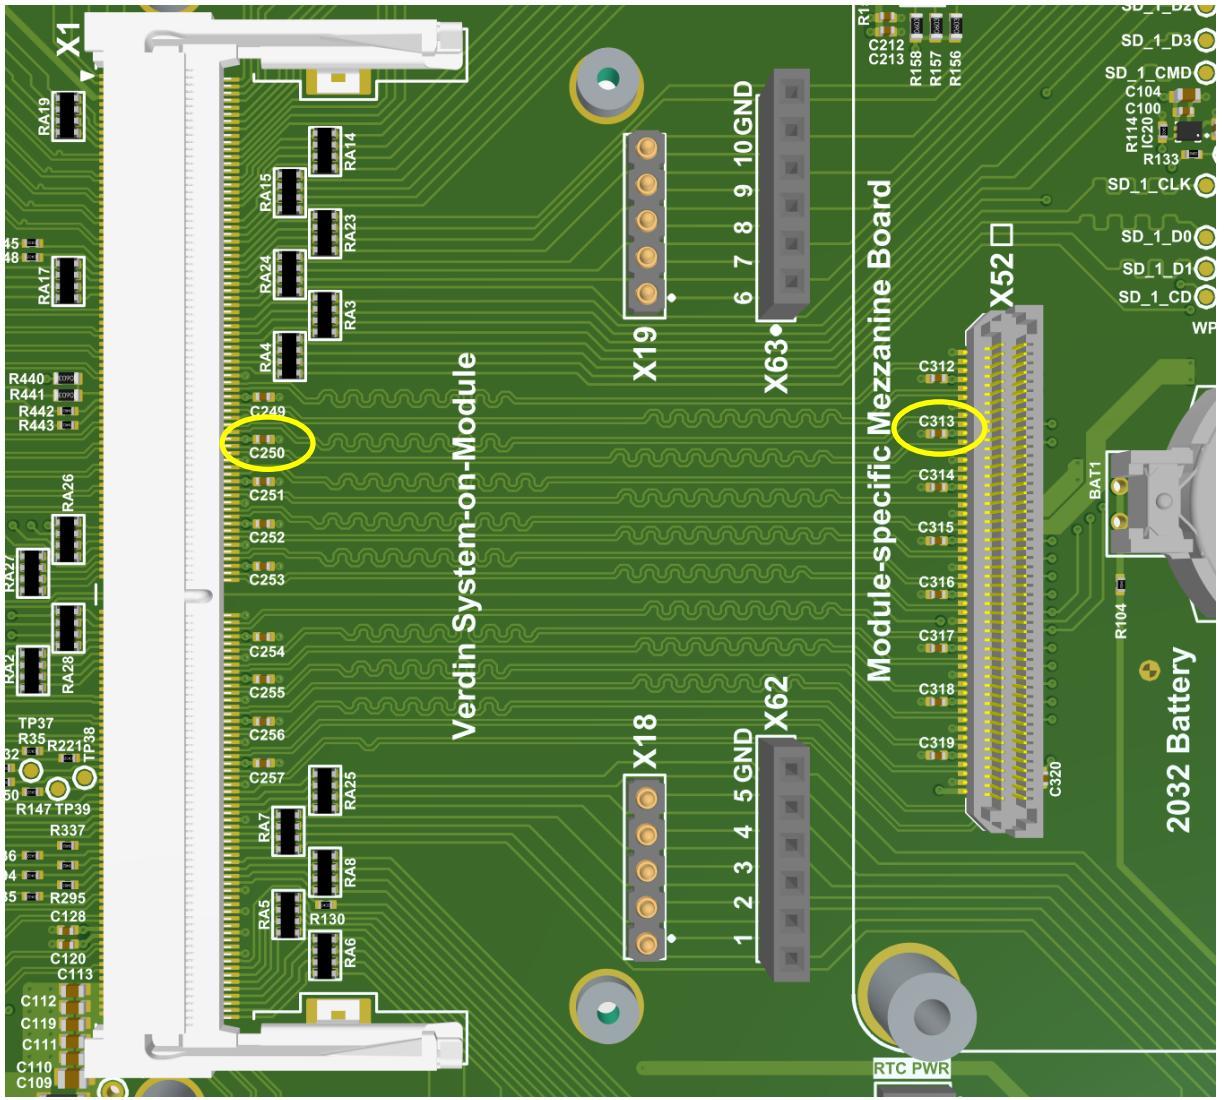
Figure 4. Location of C250 and C313 (top side)

Errata #9:	HAR-8342 – Stitching Capacitors Influence Verdin iMX8M Plus
	Bluetooth Config Strapping

The Bluetooth solution of the Wi-Fi/Bluetooth-equipped Verdin iMX8M Plus SoM is not accessible by the system as the host interface strapping signal of the Bluetooth solution is unintentionally influenced by two stitching capacitors on the carrier board. This leaves the Bluetooth solution in the UART interface mode instead of SDIO.

The Verdin Development Board V1.1A features two such capacitors (C250, C313) on the MSP_8 signal. During powering up the system, the stitching capacitors delay the transition of the related signal to the intended state and thus result in a wrong configuration being strapped. Instead of SDIO mode, the host interface of the Bluetooth solution gets configured to UART mode. As a result, the Bluetooth solution is not accessible by the system.

Remove the stitching capacitors C250 and C313 from the carrier board. This makes the Bluetooth interface work in case the carrier board is connected to a Verdin iMX8M Plus SoM with a hardware version of V1.0C or newer.

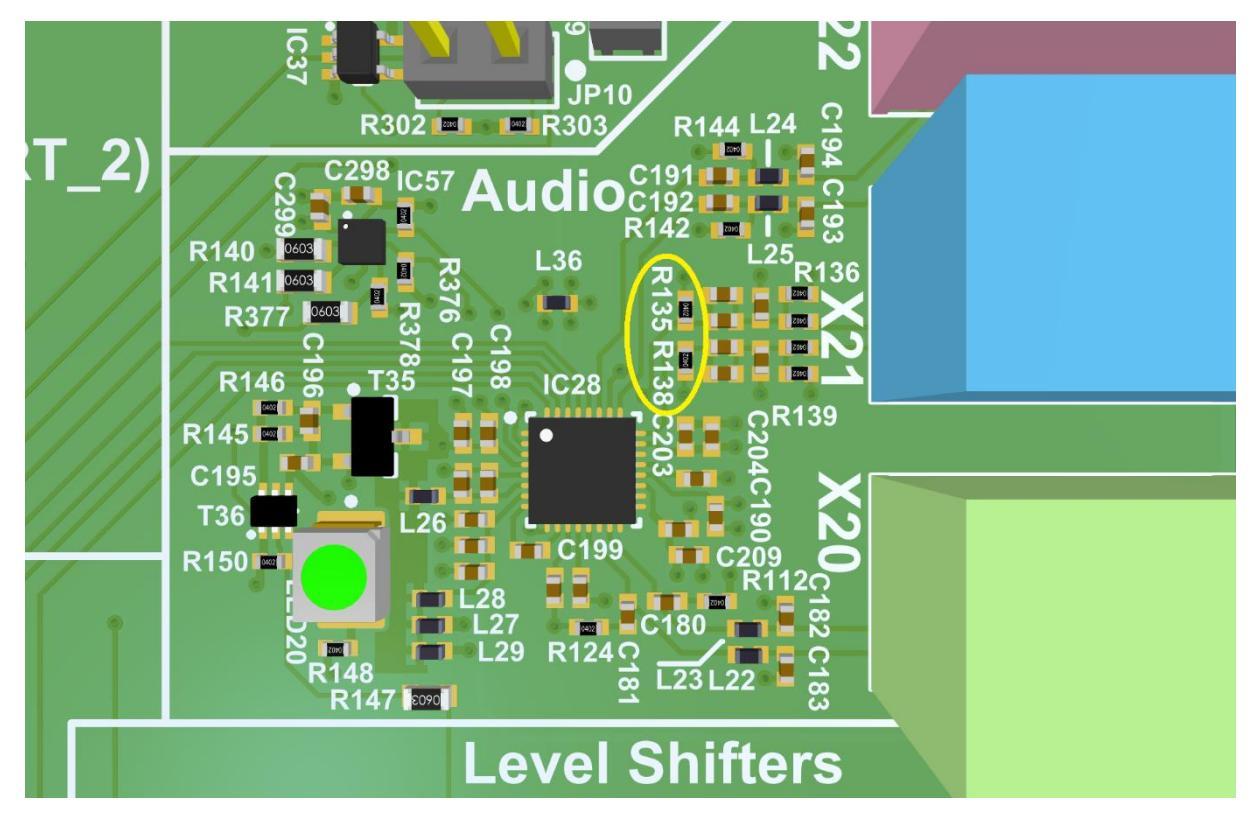
Figure 5. Location of R135 and R138 (top side)

Errata #10: HAR-8426 – Signal distortion on the audio codec's "Line In" input

The audio signals from the "Line In" input (connector X21) are distorted and the amplitudes of the signals are smaller than intended. There is crosstalk from the "Line In" input (connector X21) to the "Mic In" input (connector X22).

The 10k pull-down resistors R135 and R138 connected to the pins 26 and 24 of the audio codec (IC28) affect the functionality of the device's internal multiplexers and signal amplifiers. The analog input pins of the audio codec shift the input DC offset to their internal virtual ground VMID. The external pull-down resistors are affecting this DC offset, causing the opening of the internal multiplexer's analog signal switches and the saturation of the amplifier's outputs. This leads to the distortion of the "Line In" signals (only the positive polarity parts of the input signals are recorded) and crosstalk from the "Line In" input to the "Mic In" input.

Remove the pull-down resistors R135 and R138 from the carrier board. This makes the audio codec's "Line In" and "Mic In" inputs work properly.

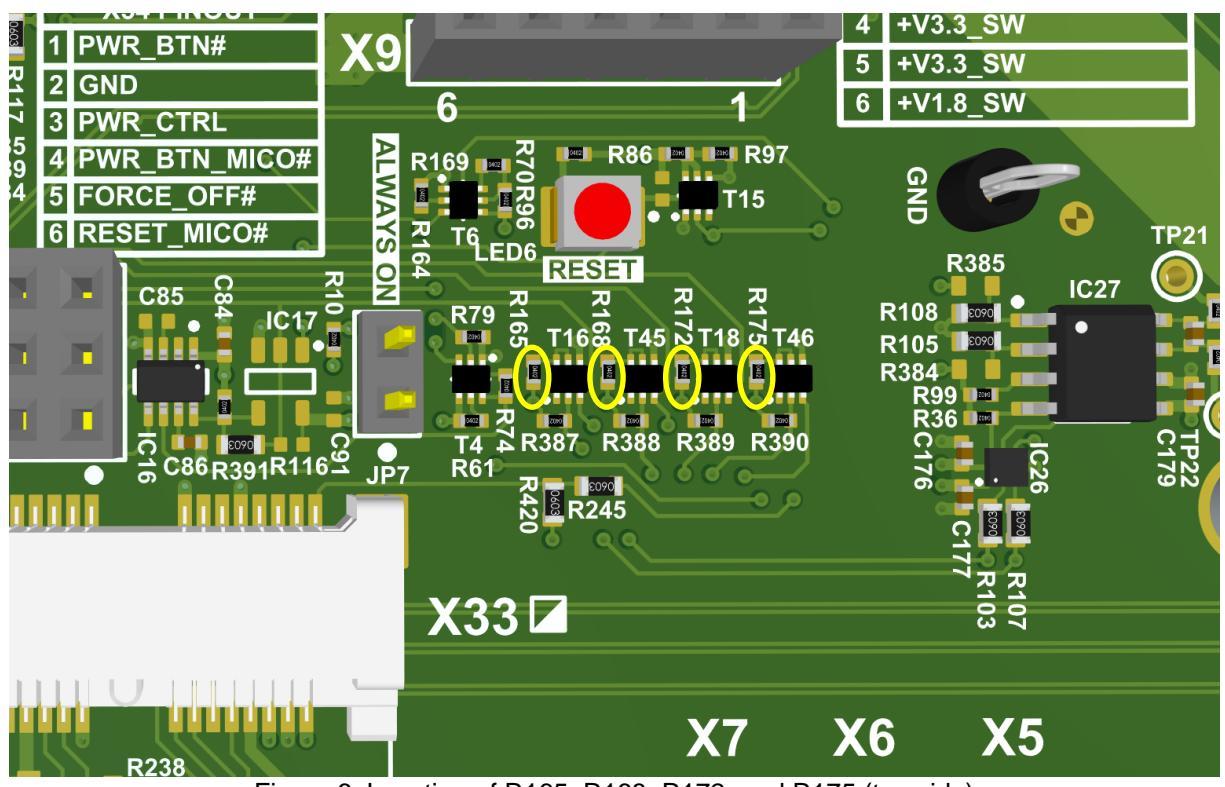
Figure 6. Location of R165, R168, R172, and R175 (top side)

Errata #11: HAR-8833 – The carrier board turns off or resets when a cable is connected to the USB-C FTDI debug connector

The module may reset or turn off, or the carrier board may turn off when a cable is being connected to the USB-C connector of the FTDI debug port while the board is turned on.

Due to a race condition between the pull-up voltage at the gates of the transistor level shifters, the DBG_PWR_BTN#, DBG_FORCE_OFF#, DBG_RESET#, DBG_RECOVERY#, and the FTDI_JTAG_TRST# signals can get unintentionally triggered when connecting a cable to the USB-C connector of the FTDI debug port. This may reset or shut down the module or shut down the power rails of the carrier board.

As an alternative solution, the resistors R165, R168, R172, R175, and R319 can be replaced with resistors having a resistance of 1MOhm. This slows down the transistor level shifter circuits and makes sure that the power control signals are not triggered when connecting the cable to the USB-C connector of the FTDI debug port. The same improvement is going to be implemented in future versions of the product.

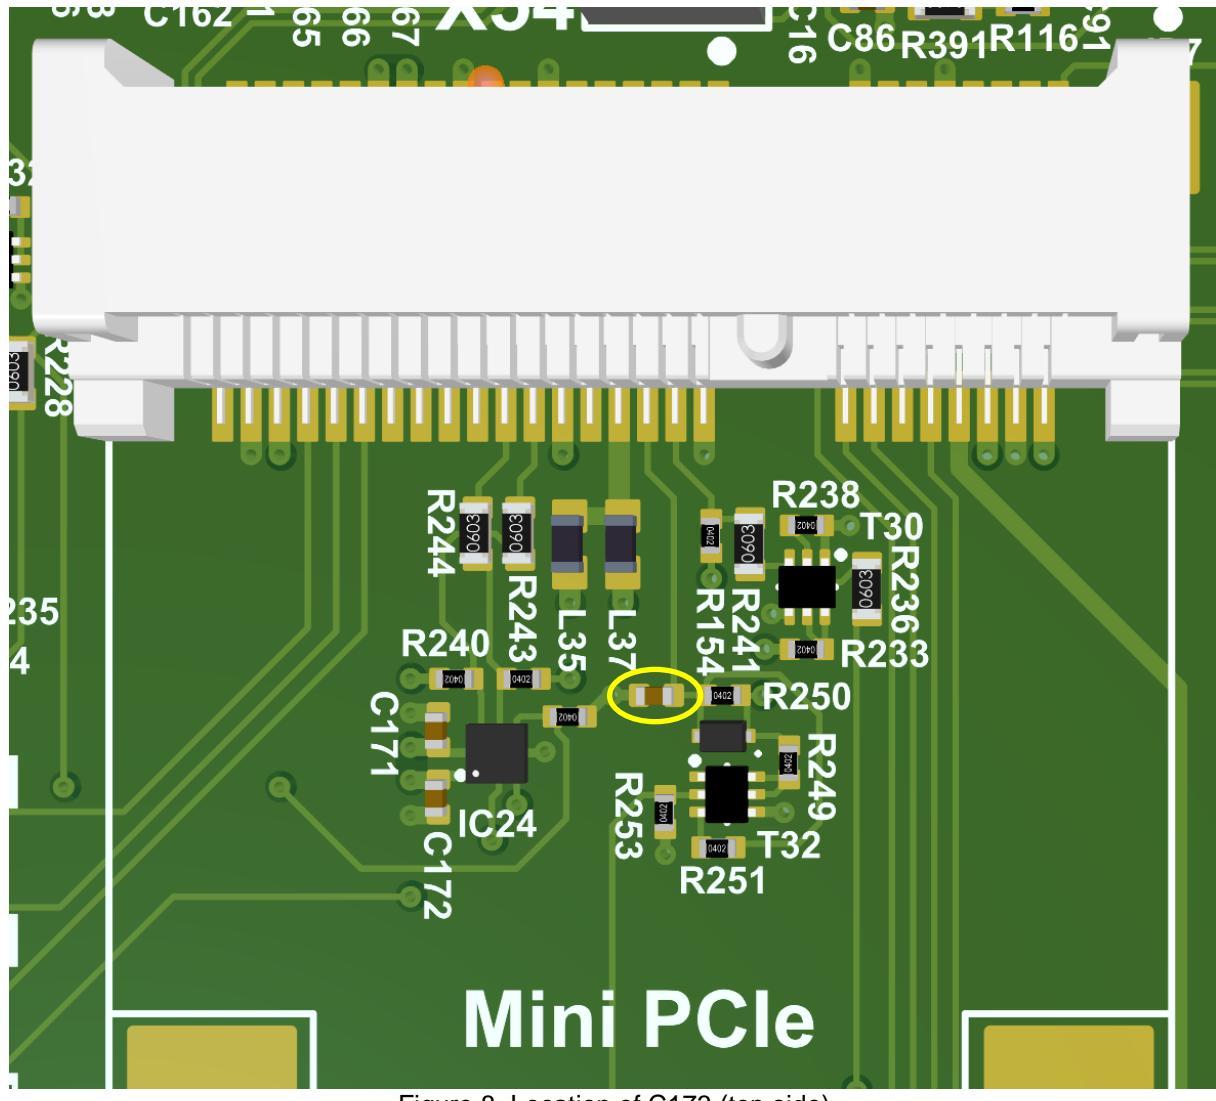
Figure 8. Location of C173 (top side)

Errata #12: HAR-8934 – The RC element on the PCIe reset signal contributes to violating the PCIe specification

PCIe devices connected to the PCIe interface of the carrier board may not get detected properly or malfunction.

The Verdin specification provides a dedicated reset signal for the PCIe interface (PCIE_1_RESET#). The Verdin Development Board features an RC delay circuit on this signal. This circuit consists of a 10uF capacitor and a 10kOhm pull-up resistor, resulting in a time constant of 100ms. The actual time it takes for the device to get out of the reset state is influenced by the threshold level of the device's reset input and component tolerances as well.

These factors together make the timing unpredictable. Consequently, a PCIe device may still be in the reset state when the driver is sending the first configuration requests. The issue does not necessarily manifest in the case of all potential PCIe devices and can be temperature-dependent as well.

By eliminating the RC delay circuit from the reset signal, the module's reset timing can be fully controlled by the PCI_1_RESET# signal. To achieve that, remove the 10uF capacitor C173. The change prevents the described issue from happening. The change is going to be implemented in future versions of the product.
