Dahlia

Errata Document

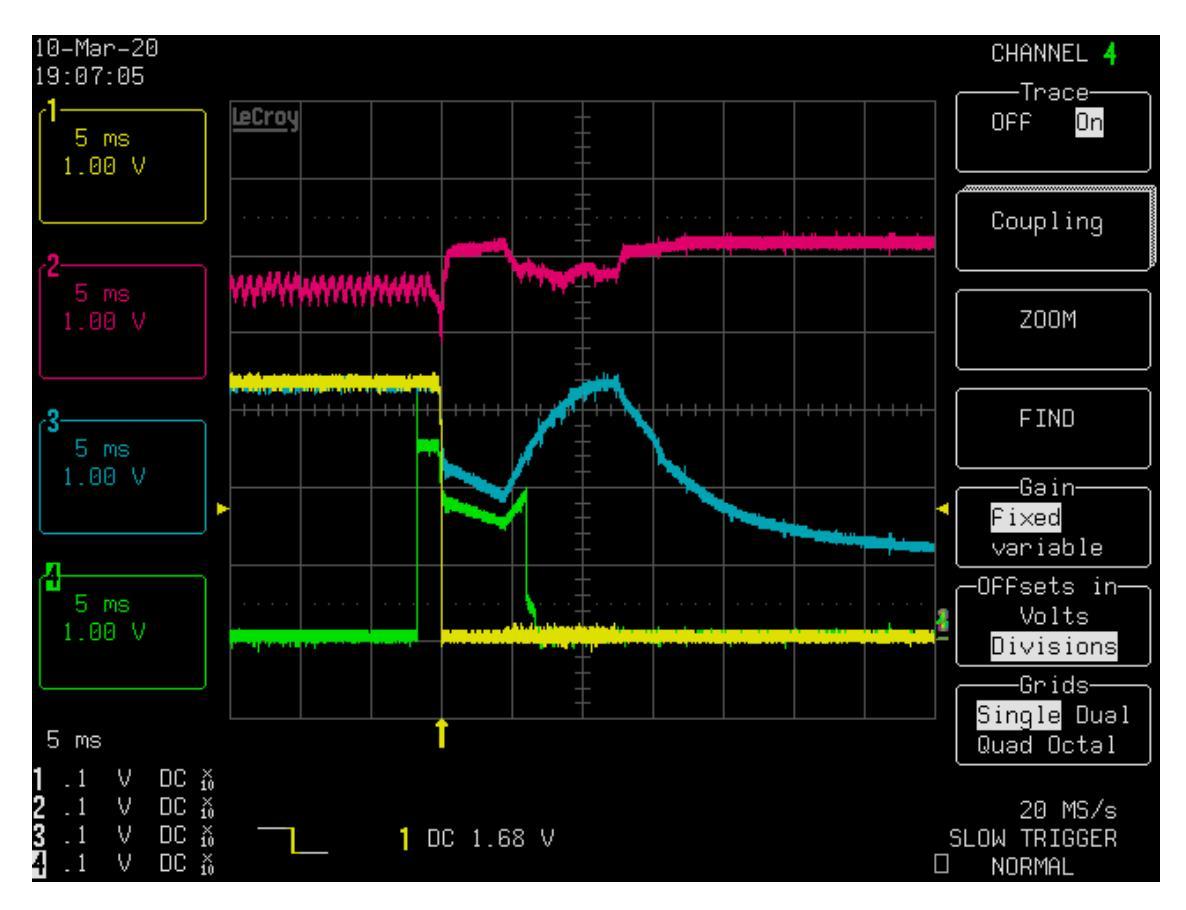
The problem is that the display's inrush current is too high when its backlight is getting enabled. When the board is powered from 5V, the display inrush current causes the +V_SUPPLY_FILT power rail on the carrier board to drop below the UVLO limit set by the voltage detection circuits built on IC13. This triggers the KILL# input of the IC10 power button controller, and it shuts down the board power supply.

Figure 1. KILL# gets triggered when the backlight is enabled CH1: KILL#, CH2: +V_SUPPLY_FILT, CH3: +V3.3, CH4: LVDS_DSI_1_BLK_EN

- Use USB-C PD power supplies with at least 9V or power the board over the barrel connector with at least 9V
- Use a good USB cable. The quality of the cables has an impact on the +V_SUPPLY_FILT voltage stability

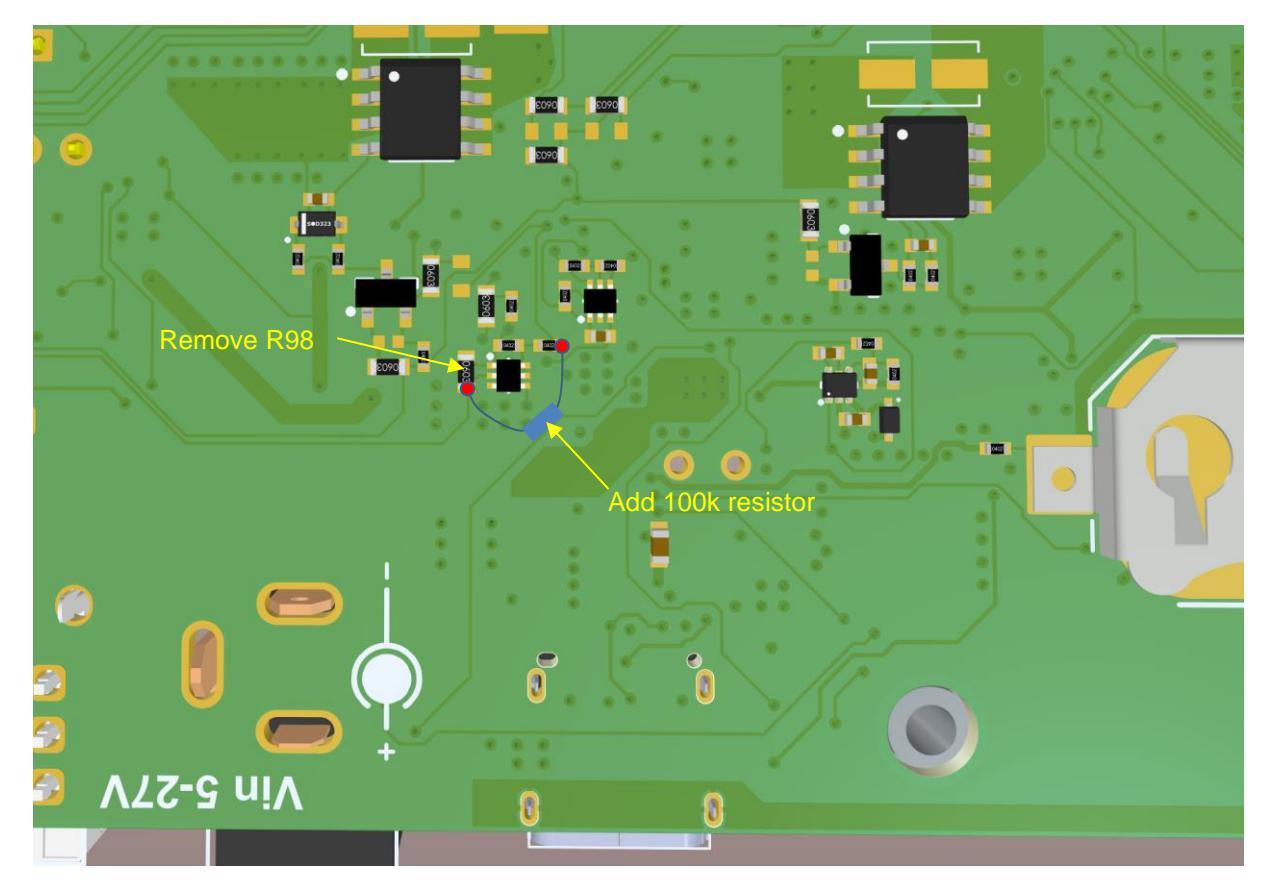
The CTRL_FORCE_OFF_MOCI# input on the Dahlia carrier board features a 1MΩ pull-down resistor instead of a pull-up resistor. In the Verdin family definition, the CTRL_FORCE_OFF_MOCI# signal is specified as an open-drain signal that is 5V tolerant. The pull-up resistor is supposed to be on the carrier board. Without this pull-up resistor, the CTRL_FORCE_OFF_MOCI# remains low and therefore is asserted all the time.

The CTRL_FORCE_OFF_MOCI# signal is permanently pulling down the kill input of the power button IC LTC2954 (IC10). The LTC2954 ignores the kill input for the first 512ms after turning it on. After this internal timer is expired, the kill signal will power off the system. This means pressing the Dahlia carrier board's power button will turn on the power only for 512ms. The power does not remain on.

Figure 2. Dahlia Carrier Board CTRL_FORCE_OFF_MOCI# pull-up resistor patch (bottom view, bottom side)

An alternate workaround is patching a 100kΩ resistor between the signal pin of R98 and the +V5_STB rail. Optionally, R98 can be removed. With this workaround, the "kill-feature" still works. However, this workaround should only be used in combination with a newer Verdin module (e.g. Verdin iMX8M Mini V1.1A, Verdin iMX8M Plus V1.0A) on which the CTRL_FORCE_OFF_MOCI# is an open-drain type. For the older Verdin iMX8M Mini V1.0B module, the CTRL_FORCE_OFF_MOCI# is not 5V tolerant, and the CTRL_FORCE_OFF_MOCI# signal gets also asserted during the reset cycle. This means after the modification, the Dahlia carrier board is not compatible anymore with the Verdin iMX8M Mini V1.0B. Read Errata #13 and Errata #5 of the Verdin iMX8M Mini V1.0B module for more information. The following picture shows one potential implementation of the alternate workaround patch:

Add a 100k Ω resistor between the signal pin of R98 and the +V5_STB rail. Optionally, R98 can be removed. This workaround enables the "kill-feature". However, the modified carrier board should only be used in combination with a newer Verdin module (e.g., Verdin iMX8M Mini V1.1A, Verdin iMX8M Plus V1.0A) on which the CTRL_FORCE_OFF_MOCI# is an open-drain type. For the older Verdin iMX8M Mini V1.0B module, the CTRL_FORCE_OFF_MOCI# is not 5V tolerant, and the CTRL_FORCE_OFF_MOCI# signal gets also asserted during the reset cycle. This means after the modification, the Dahlia carrier board is not compatible anymore with the Verdin iMX8M Mini V1.0B. Read Errata #13 and Errata #5 of the Verdin iMX8M Mini V1.0B module for more information. See also Figure 2 in Errata #4 for the location of R98 and the +V5_STB rail.

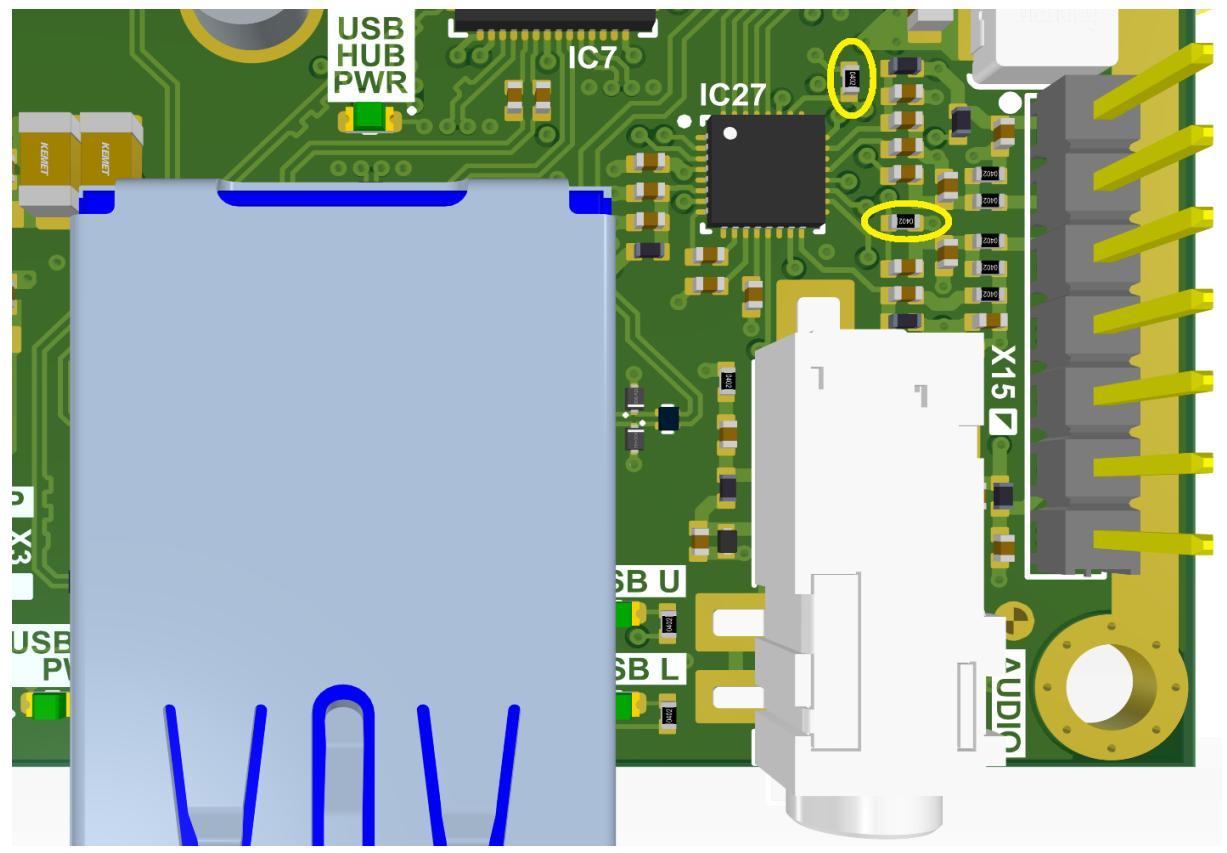
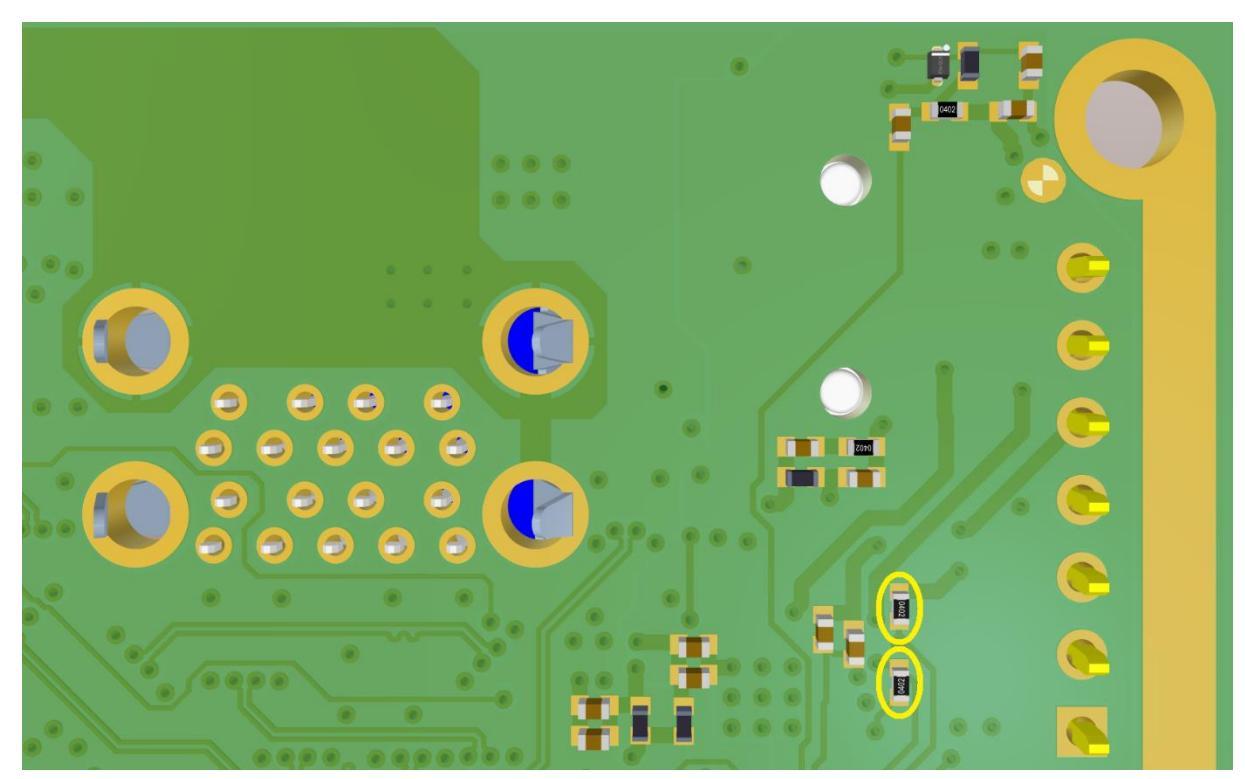
The audio signals from the "Line In" input (connector X15) are distorted and the amplitudes of the signals are smaller than intended. There is crosstalk from the "Line In" input (connector X15) to the "Mic In" input (connector X14).

The 10k pull-down resistors R251 and R254 connected to the pins 26 and 24 of the audio codec (IC28) affect the functionality of the device's internal multiplexers and signal amplifiers. The analog input pins of the audio codec shift the input DC offset to their internal virtual ground VMID. The external pull-down resistors are affecting this DC offset, causing the opening of the internal multiplexer's analog signal switches and the saturation of the amplifier's outputs. This leads to the distortion of the "Line In" signals (only the positive polarity parts of the input signals are recorded) and crosstalk from the "Line In" input to the "Mic In" input.

Figure 3. Location of R251 and R254 in the V1.1 version (top view, top side)

Figure 4. Location of R251 and R254 in the V1.0 version (bottom view, bottom side)

Remove the pull-down resistors R251 and R254 from the carrier board. This makes the audio codec's "Line In" and "Mic In" inputs work properly.

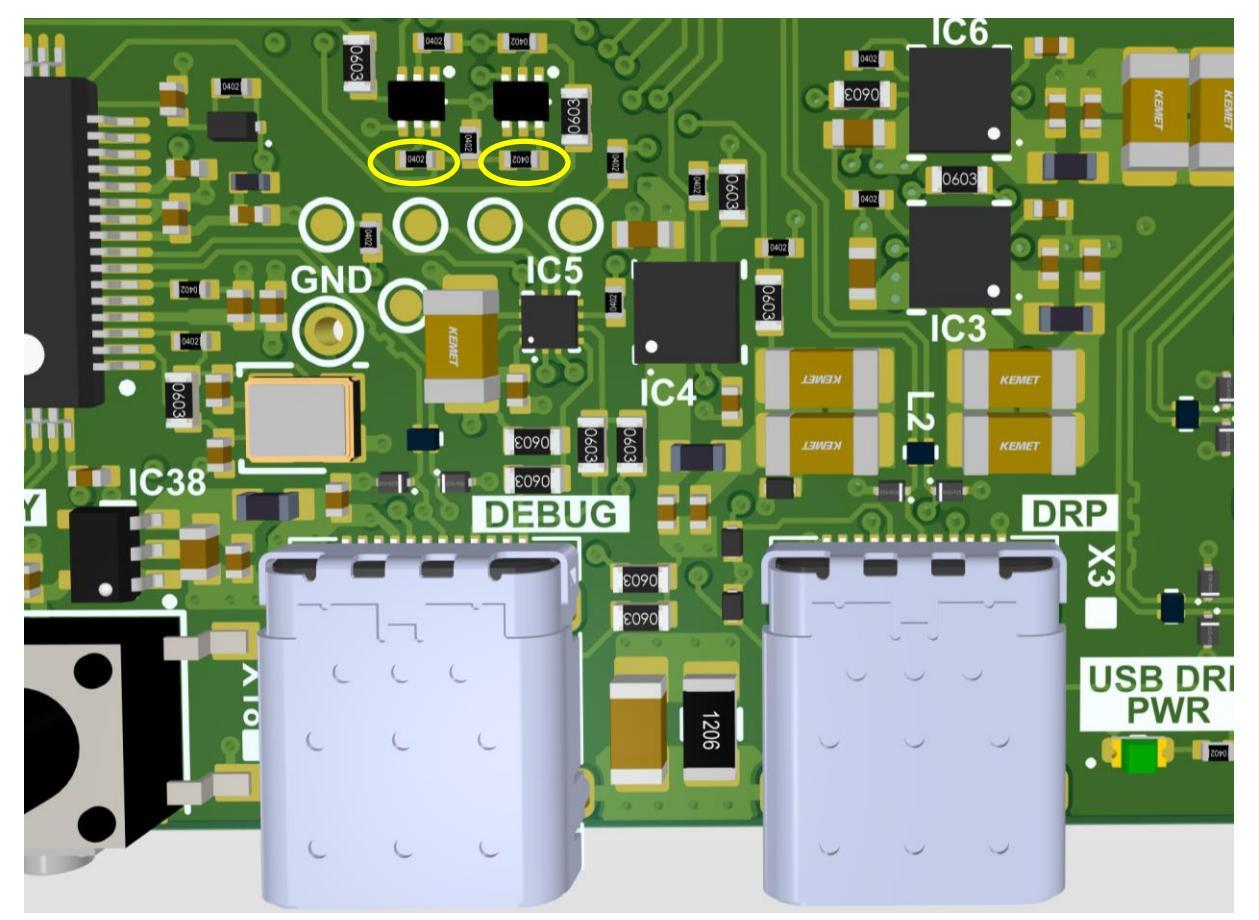
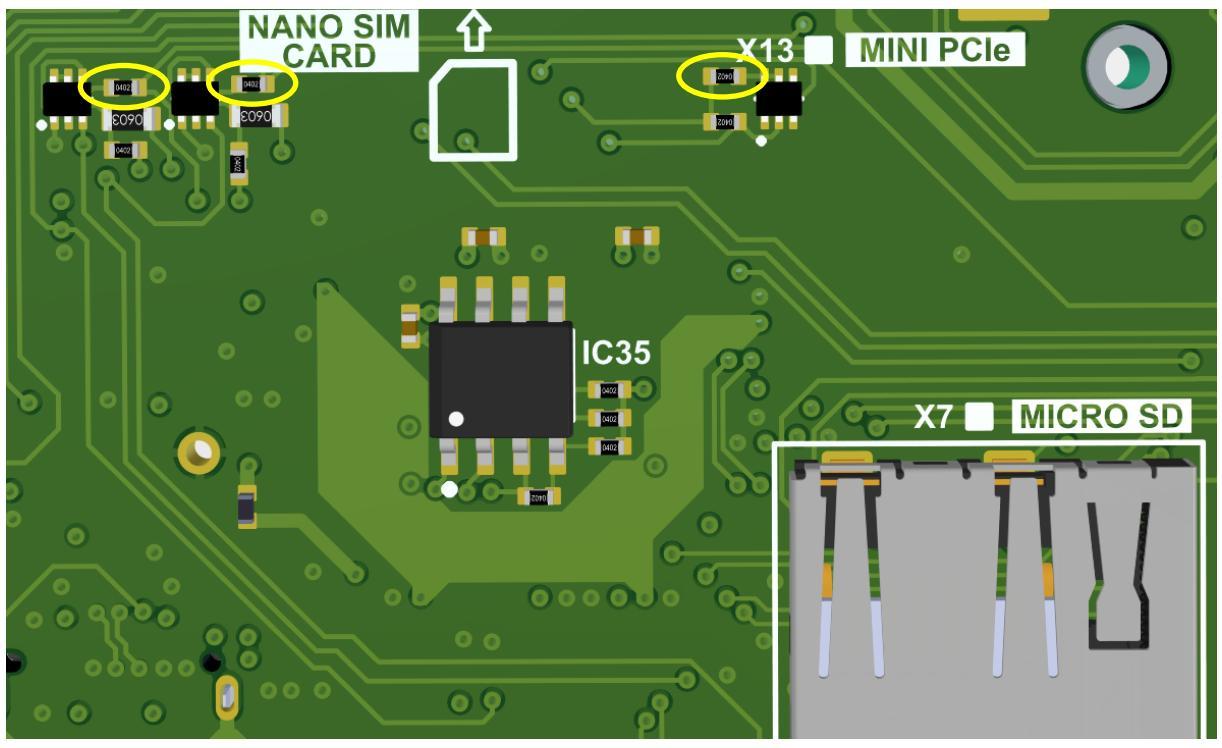
Due to a race condition between the pull-up voltage at the gates of the transistor level shifters, the DBG_PWR_BTN#, DBG_FORCE_OFF#, DBG_RESET#, DBG_RECOVERY#, and the FTDI_JTAG_TRST# signals can get unintentionally triggered when connecting a cable to the USB-C connector of the FTDI debug port. This may reset or shut down the module or shut down the power rails of the carrier board.

Figure 5. Location of R102 and R120 in the V1.1 version (top view, top side)

Figure 6. Location of R109, R115, and R245 in the V1.1 version (bottom view, bottom side)

Connect the cable to the USB-C connector of the FTDI debug port before powering on the carrier board. As an alternative solution, the resistors R102, R109, R115, R120, and R245 can be replaced with resistors having a resistance of 1MOhm. This slows down the transistor level shifter circuits and makes sure that the power control signals are not triggered when connecting the cable to the USB-C connector of the FTDI debug port. The same improvement is going to be implemented in future versions of the product.

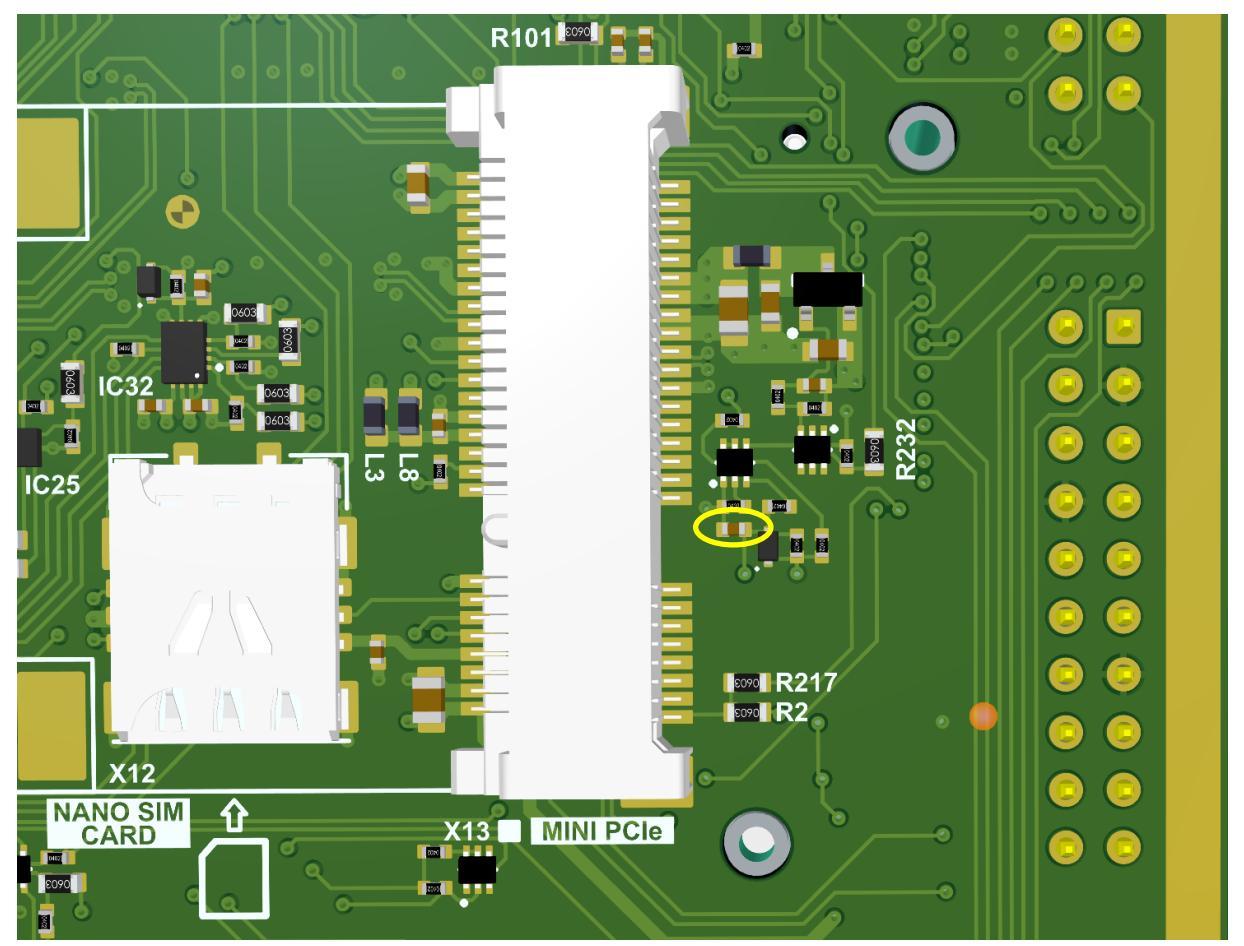
The Verdin specification provides a dedicated reset signal for the PCIe interface (PCIE_1_RESET#). The Dahlia Carrier Board features an RC delay circuit on this signal. This circuit consists of a 10uF capacitor and a 10kOhm pull-up resistor, resulting in a time constant of 100ms. The actual time it takes for the device to get out of the reset state is influenced by the threshold level of the device's reset input and component tolerances as well.

These factors together make the timing unpredictable. Consequently, a PCIe device may still be in the reset state when the driver is sending the first configuration requests. The issue does not necessarily manifest in the case of all potential PCIe devices and can be temperature-dependent as well.

Figure 7. Location of C141 in the V1.1 version (bottom view, bottom side)

By eliminating the RC delay circuit from the reset signal, the module's reset timing can be fully controlled by the PCI_1_RESET# signal. For achieving that, remove the 10uF capacitor C141. The change prevents the described issue from happening. The change is going to be implemented in future versions of the product.
