# Product Change Notification (PCN): 0025 Apalis T30 2GB V1.1B, 0026 Apalis T30 V1.1B and 0031 Apalis T30 1GB IT V1.1B to versions V1.1Z

Date of publication: 25 Apr 2023

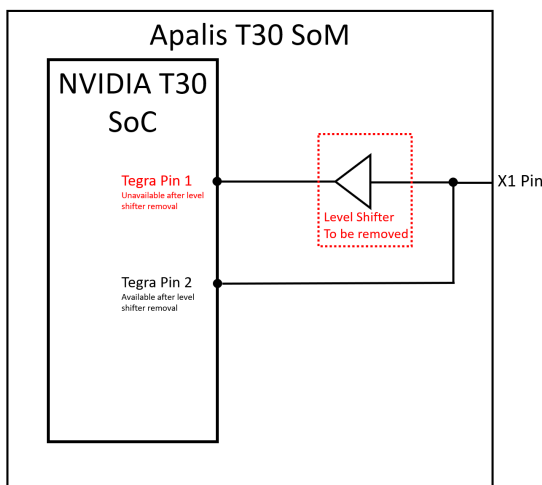
**Affected Pins on SODIMM Connector X1**

- Parallel camera interface won't be available in V1.1Z
- No changes are required on the Apalis carrier board
- SoM Pins affected by this change are : 99, 123, 135, 159, 173, 175, 177, 179, 181, 183, 185, 187, 191, 195, 197 (Figure 5 and Table 5-54 in [Apalis T30 datasheet](#))
- All the affected SoM pins multiplexed. They are connected to 2 pins on the SoC-side (see Table 4-1 - Apalis T30 Multiplexed Pins in [Apalis T30 datasheet](#))

X1 Pin#	Tegra Pin 1	Tegra pin 2
99	VI_D11	KB_COL5
123	VI_D10	KB_COL6
135	VI_D0	KB_ROW8
159	VI_D1	KB_ROW9
173	VI_D9	KB_ROW7
175	VI_D8	KB_ROW6
177	VI_D7	KB_ROW5
179	VI_D6	KB_ROW4
181	VI_D5	KB_ROW3
183	VI_D4	KB_ROW2
185	VI_D3	KB_ROW1
187	VI_D2	KB_ROW0
191	VI_PCKL	KB_COL2
195	VI_VSYNC	KB_COL3
197	VI_HSYNC	KB_COL4
