## TEST REPORT

EN 60068-2-6:2008

Test Fc: "Vibration (sinusoidal)"

<b>Report reference no:</b>	U2243-22a-18

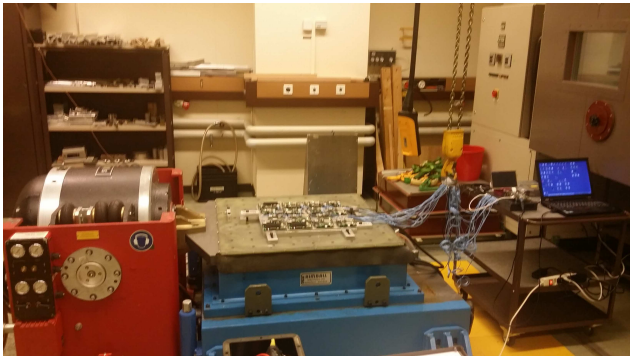
Axis 1

Vibration axes:

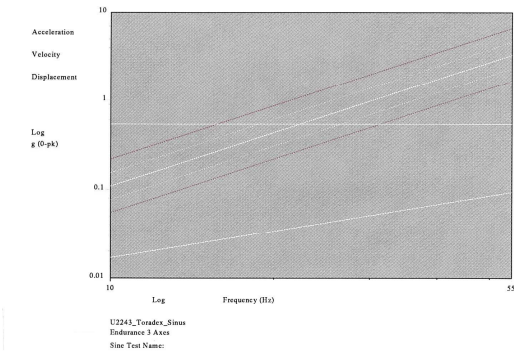
Reference

Vibration diagrams:

<b>Test specification:</b>	
Standards:	EN 60068-2-6:2008
Test purpose:	Type testing for Swiss and EU legal requirements
Procedure deviation:	none
Specimen:	unpacked
Frequency range:	10Hz.....55Hz
Vibration amplitude: (displacement or/and acceleration)	0.54mm (constant amplitude/displacement)
Peak acceleration (@ 55Hz):	3.2 m/s <sup>2</sup>
Endurance procedure:	by sweeping
Specimen is operating:	yes
Duration of endurance:	2 hours / axis
Sweep rate (exponential):	1 octave per min.
Axes of vibration:	in all 3 main axes
Single or multiple control:	single
Choice of control points:	see photograph / according to customer's specification
Vibration response investigation:	none
<b>Test procedure and measurements:</b>	
Date of testing:	16 May-24 May 2018
Details of mounting or supports:	see photographs
Initial test: - visual inspection: - mechanical and electrical measurements:	<b>Passed</b>  All the DUTs have been tested by the customer with the default functional testing (FCT): <b>no issues detected.</b>
