Colibri iMX6

Errata Document

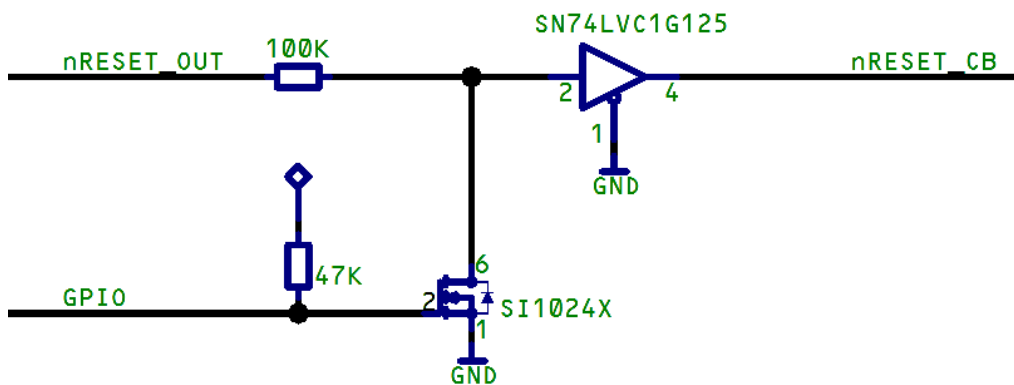
A possible workaround is implementing a small reset circuit on the carrier board that allows driving low the reset signal by using any free GPIO:

Since on the Colibri iMX6 the reset state of regular GPIOs is configured as input with enabled internal pull up resistor, the transistor will pull down the reset line during a software initiated reset cycle. The bootloader or application needs to reconfigure the GPIO as output and drive it low for releasing the external reset signal.

During a software initiated reset cycle, the nRESET_OUT signal is not asserted on the Colibri iMX6 V1.0 module. Unlike other Colibri modules, the nRESET_OUT signal remains the whole time high during the software initiated reset.

During power up as well as hardware initiated reset cycles (by pressing the nRESET_IN/RESET_EXT button), the nRESET_OUT signal gets asserted similar to other Colibri modules. This is not an issue as long as external peripheral devices on the carrier board do not need to be reset during a software reset or no software initiated reset cycles are used on a system.

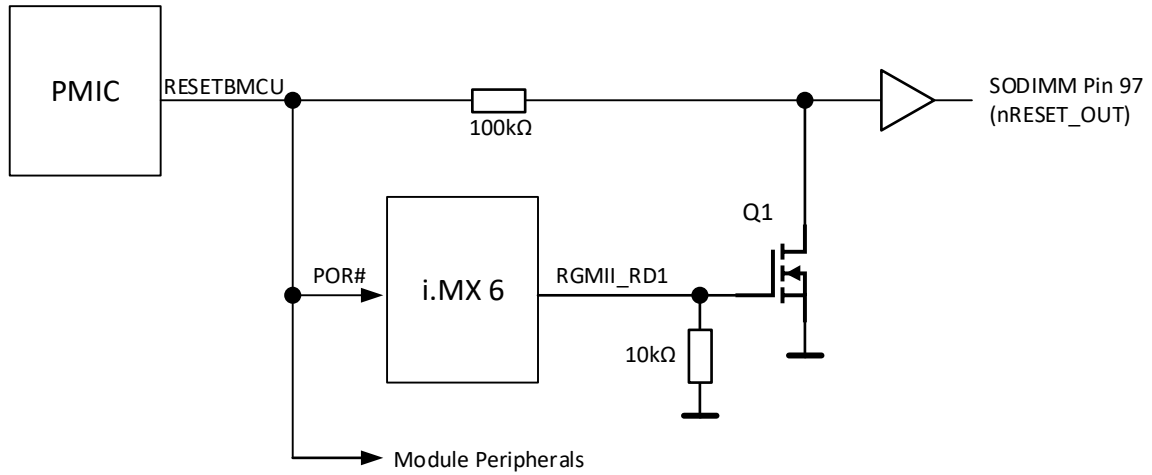
Beginning with the Colibri iMX6 V1.1, a circuit has been implemented on the module similar to the proposed workaround (see picture below). The module can drive the nRESET_OUT signal low by setting the RGMII_RD1 pin of the SoC (GPIO6_IO27) high. The pull down resistor on this line makes sure that the circuit is compatible with older software versions which do not drive the RGMII_RD1 pin. The proposed workaround circuit for V1.0 is still compatible with the module V1.1.
