TEST REPORT

EN 60068-2-27:2009

Test Ea: "mechanical Shock"

Report reference no: U2243-25a-18
Simulation carried out by: B. Belegu
Approved by management: D. Vonarburg, Technical Manager
Date of issue: 28 may 2018
Number of pages: 5 pages

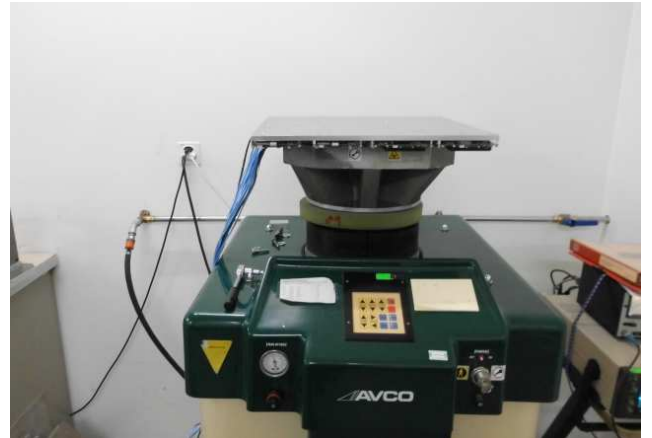
Axis 1:

Photographs:**Shock axes:**

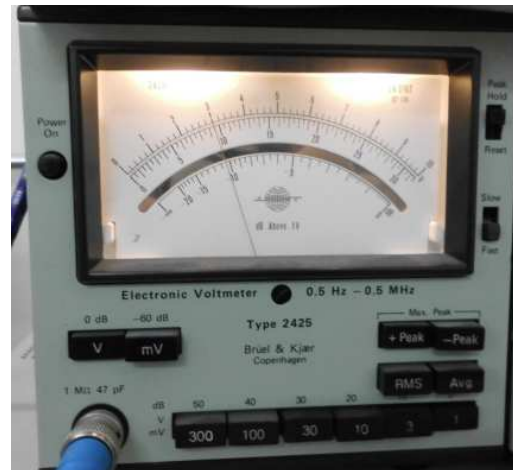
Diagrams:

Reference 30g, 18ms

Shock diagram: 30g/18ms, 100mV/div, Sensor=10mV/g, 3Div=ΔV=30g

Shock level=30g, skala (0-100)g, (0-1)V, 1V=100g, 0.3V =30g, Sensor Sens.=10mV/g
