TEST REPORT

Environmental Testing

EN 60068-2-27:2009

Test Ea: "mechanical Shock"

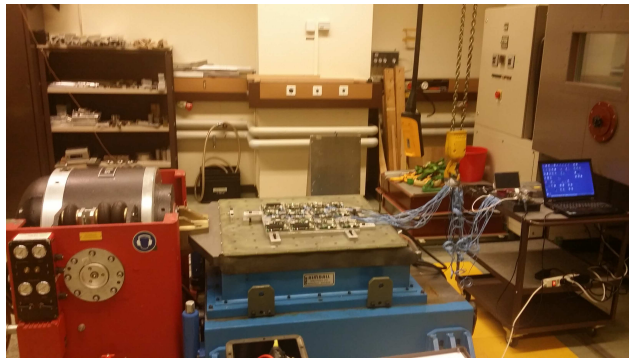
Axis 1

Shock axes:

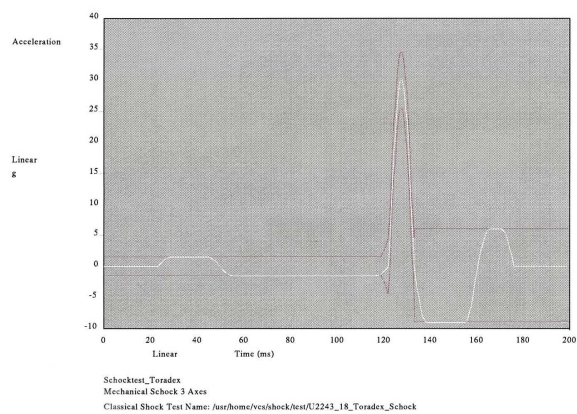
Shock diagrams:

Reference

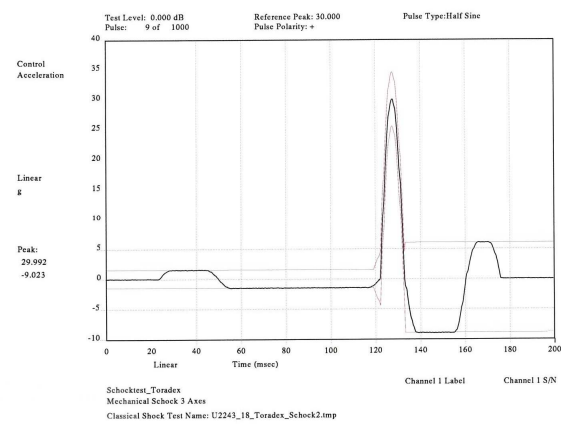
Test positive

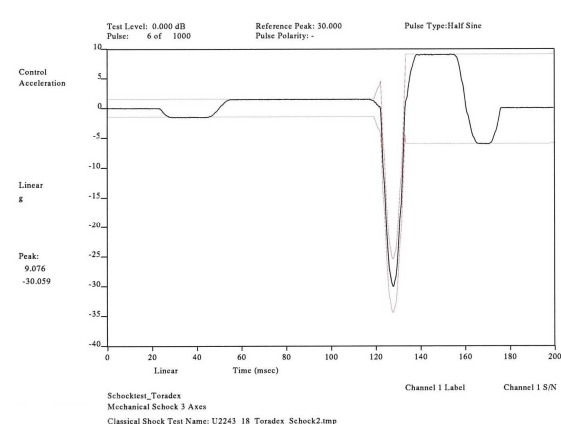
Test negative
